# **The Siqueiros Legacy: Challenges of Conserving the Artist's Monumental Murals**

Proceedings of a Symposium Organized by  
The Getty Conservation Institute

October 16–17, 2012

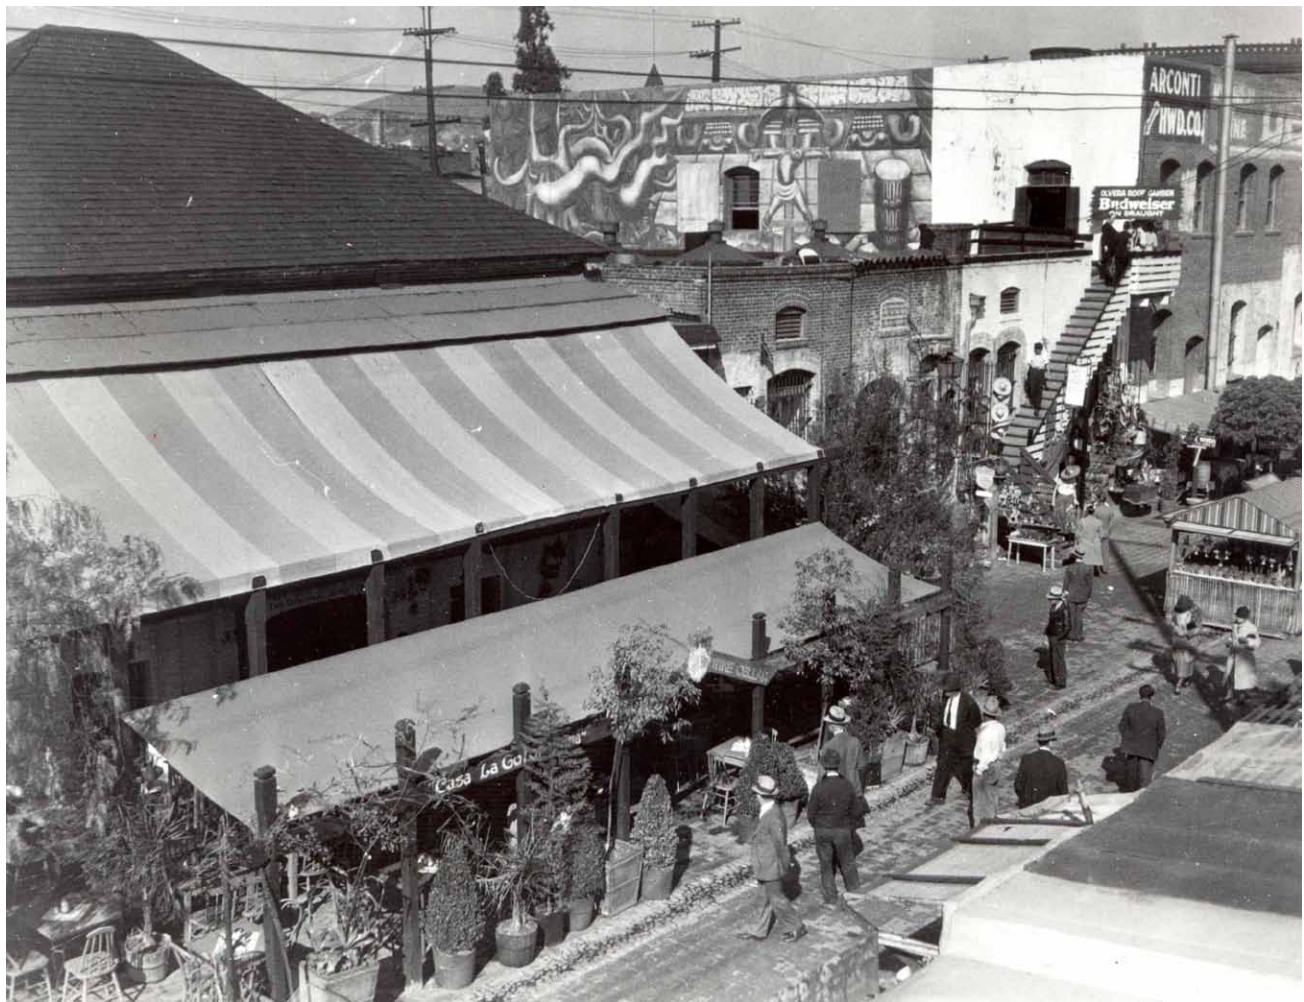
**Figure 2** View of the mural from Olvera Street taken by a *Los Angeles Times* staff photographer circa 1934. The east portion of *América Tropical*, which could be seen from Olvera Street, was whitewashed shortly after the mural was completed. Photo: © Los Angeles Times, photo published June 22, 2004; mural: © 2012, Artists Rights Society (ARS), New York/Sociedad Mexicana de Autores de las Artes Plásticas (SOMAAP), Mexico City

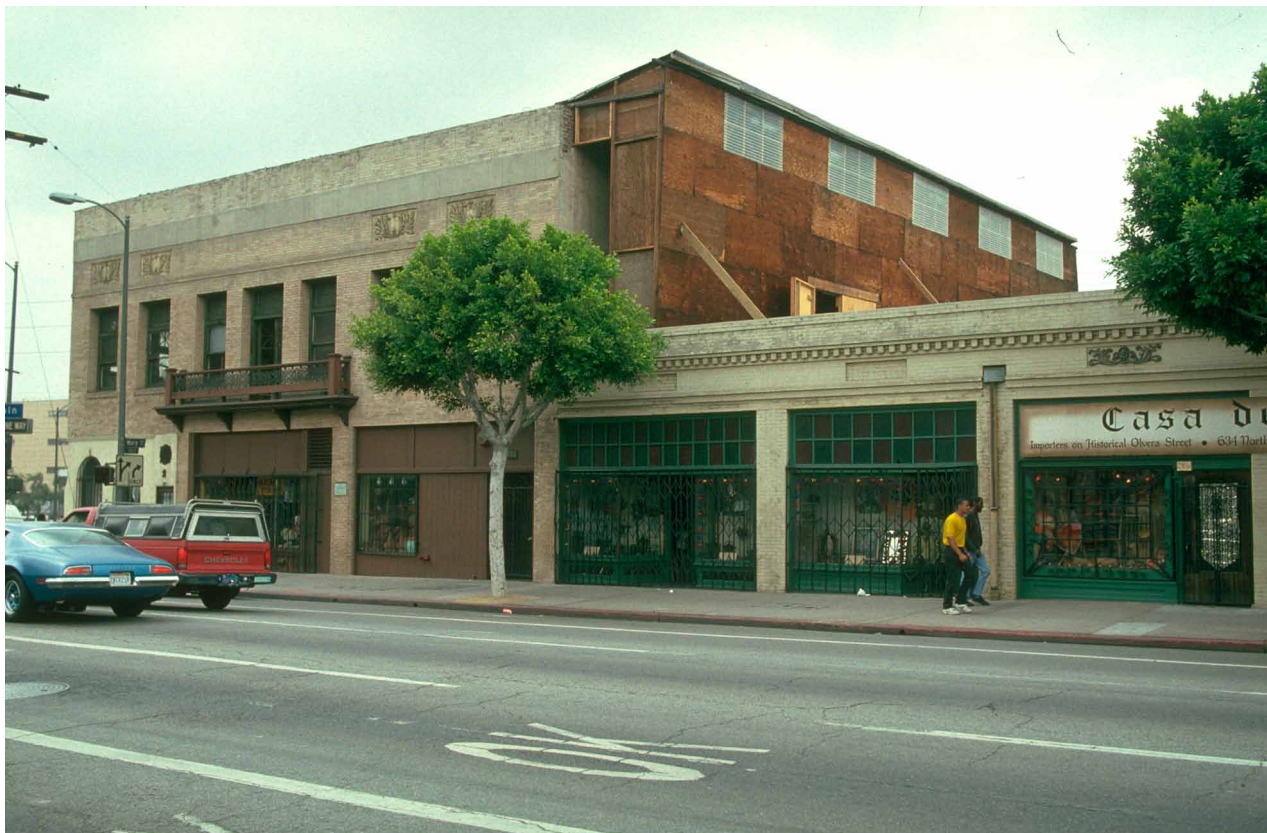
**Figure 3** A temporary shelter erected over *América Tropical*, circa 1990. From the 1980s on, a series of temporary shelters was erected over the mural to protect it while funding was secured and conservation plans were developed.

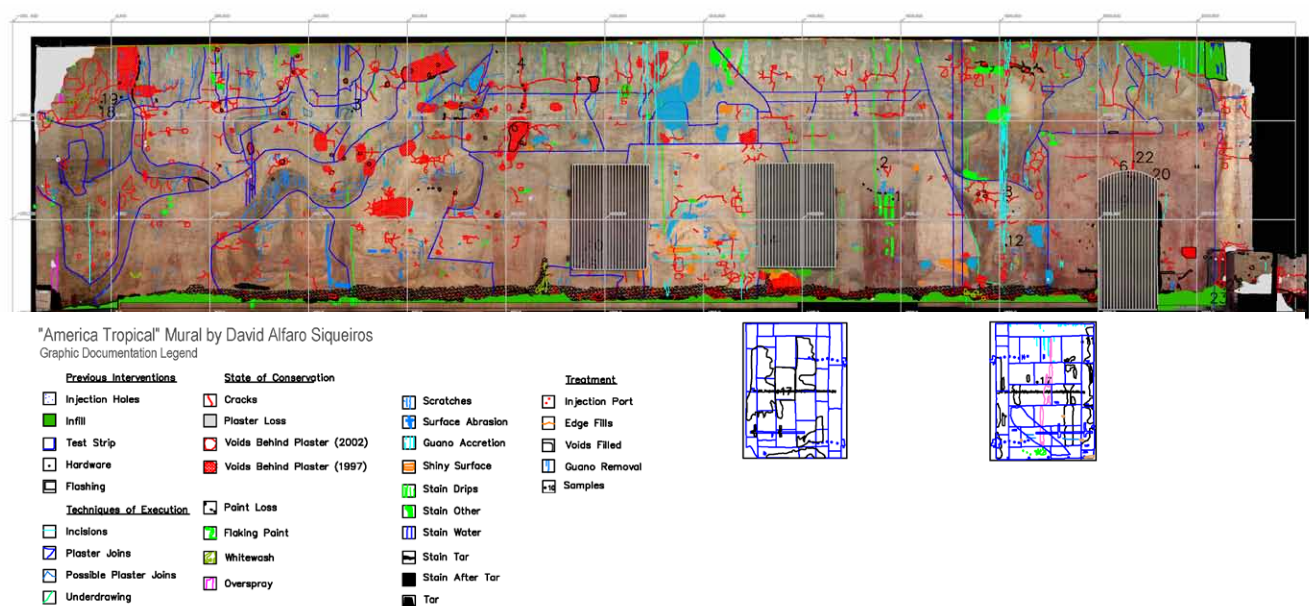
**Figure 4** Mural base map with condition-recording layers over it. Mural: © 2012, Artists Rights Society (ARS), New York/Sociedad Mexicana de Autores de las Artes Plásticas (SOMAAP), Mexico City

During the 1990s, the GCI carried out extensive documentation of *América Tropical*, including photographic documentation before and after a preliminary phase of conservation in 1990, followed by an early digital capture of the mural in 1993, in which individual detail sections were photographed, then tiled together, a process that resulted in a rectified, high-resolution image of the mural (Lange 1996). This image has been used as a base map for the condition recording performed since then,<sup>6</sup>

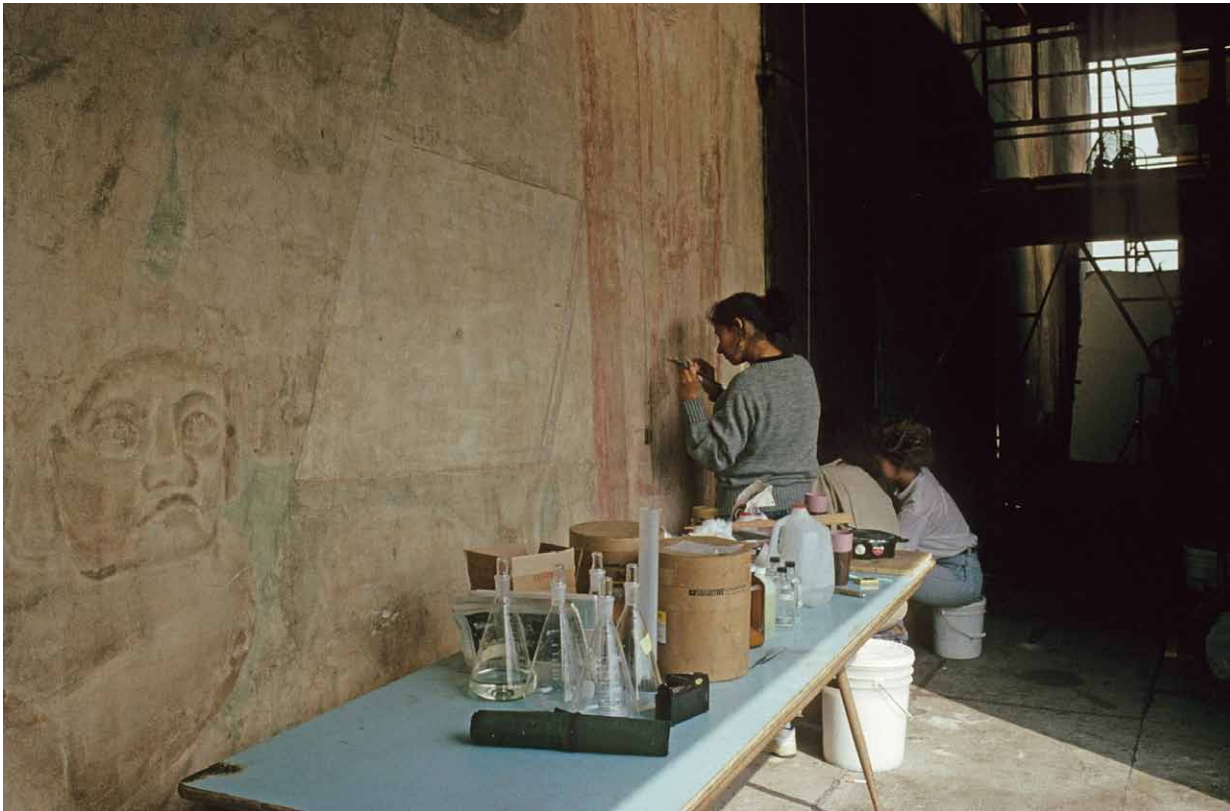
**Figure 5** Conservation treatment of the mural. In 1990 a team of conservators led by Agustín Espinosa performed preliminary treatment, including surface cleaning, reattachment of plaster to the wall, removal of tar, and surface consolidation. Photo: Nancy Kaye, © J. Paul Getty Trust; mural: © 2012, Artists Rights Society (ARS), New York/Sociedad Mexicana de Autores de las Artes Plásticas (SOMAAP), Mexico City

The GCI has carried out three phases of conservation treatment—in 1990, 2002, and 2012. Preliminary treatment in 1990 addressed surface cleaning and consolidation, reattachment of plaster to the brick substrate, whitewash removal, and removal of tar from the base of the mural (Espinosa 1990; Paine 1990; Stewart 1990) (fig. 5). Further plaster stabilization was carried out in 2002 (Rainer 2002–3), and in 2012, the most recent campaign of conservation was carried out. This treatment included cleaning, additional stain and tar stain reduction and removal, reattachment of plaster, filling of losses, surface consolidation, and visual reintegration (Rainer 2013).

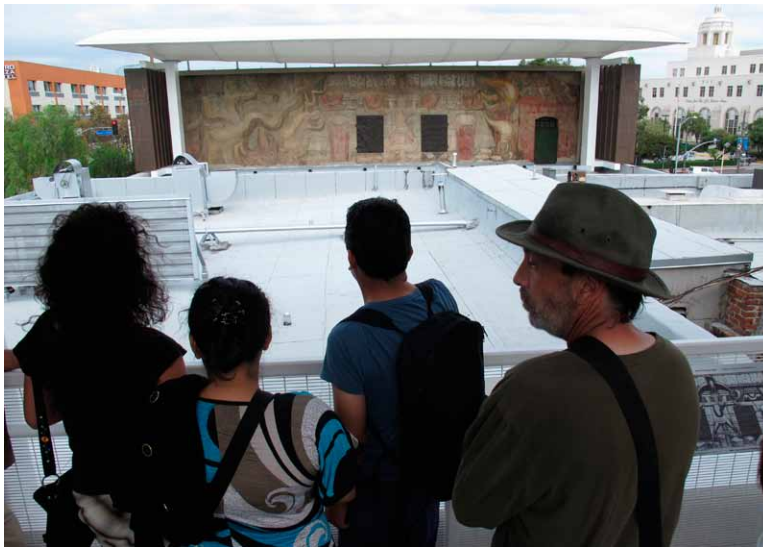
**Figure 6** The mural with its protective canopy, seen from the viewing platform at the opening of the site in October 2012. The canopy protects the mural from direct sunlight, rain, and birds and allows an unobstructed view of the mural from a nearby rooftop. Mural: © 2012, Artists Rights Society (ARS), New York/ Sociedad Mexicana de Autores de las Artes Plásticas (SOMAAP), Mexico City

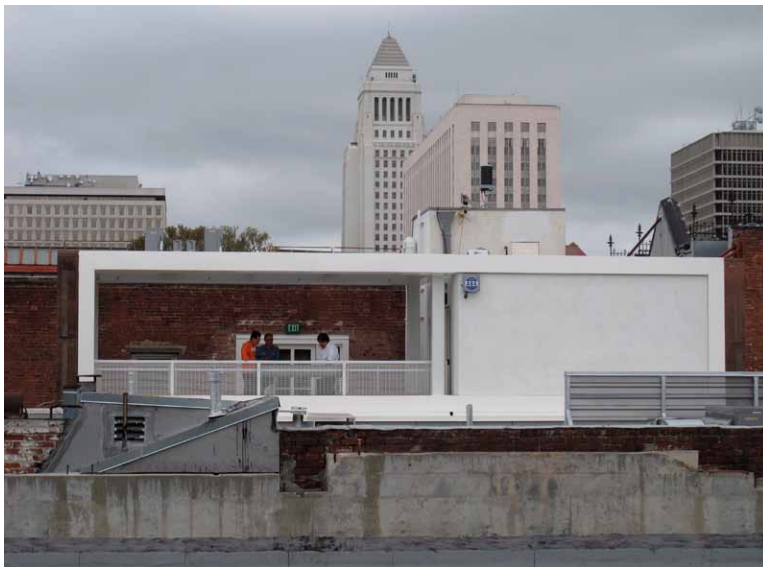
**Figure 7** The viewing platform, designed by Brooks + Scarpa Architects, which is accessible from the América Tropical Interpretive Center. Up to twenty visitors can view the mural at one time. A large black-and-white image of the mural positioned on a rail of the platform provides information on the painting's iconography

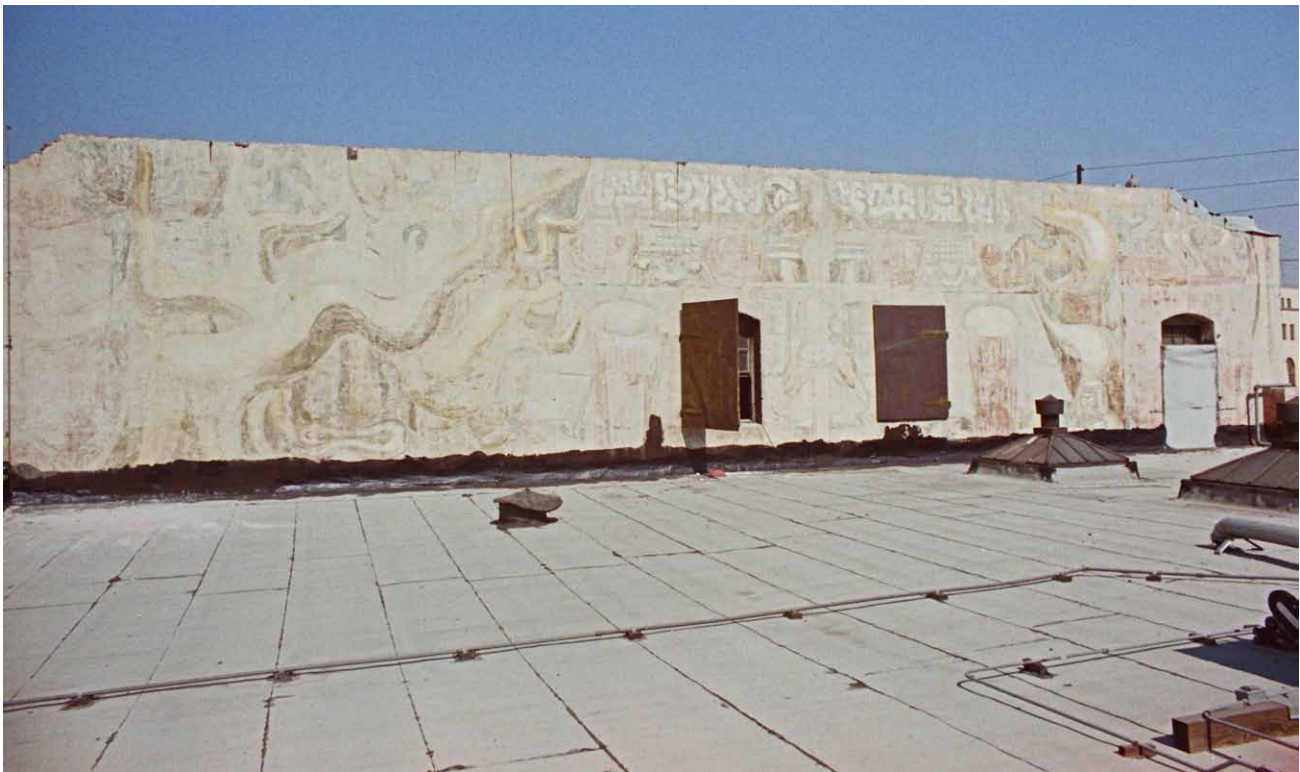
**Figure 1** The *América Tropical* mural in 1971, after the earthquake of February 9, 1971. Earthquake damage can be seen at the upper right and upper left corners. Photo: Jesús Salvador Treviño; mural: © 2012, Artists Rights Society (ARS), New York/Sociedad Mexicana de Autores de las Artes Plásticas (SOMAAP), Mexico City

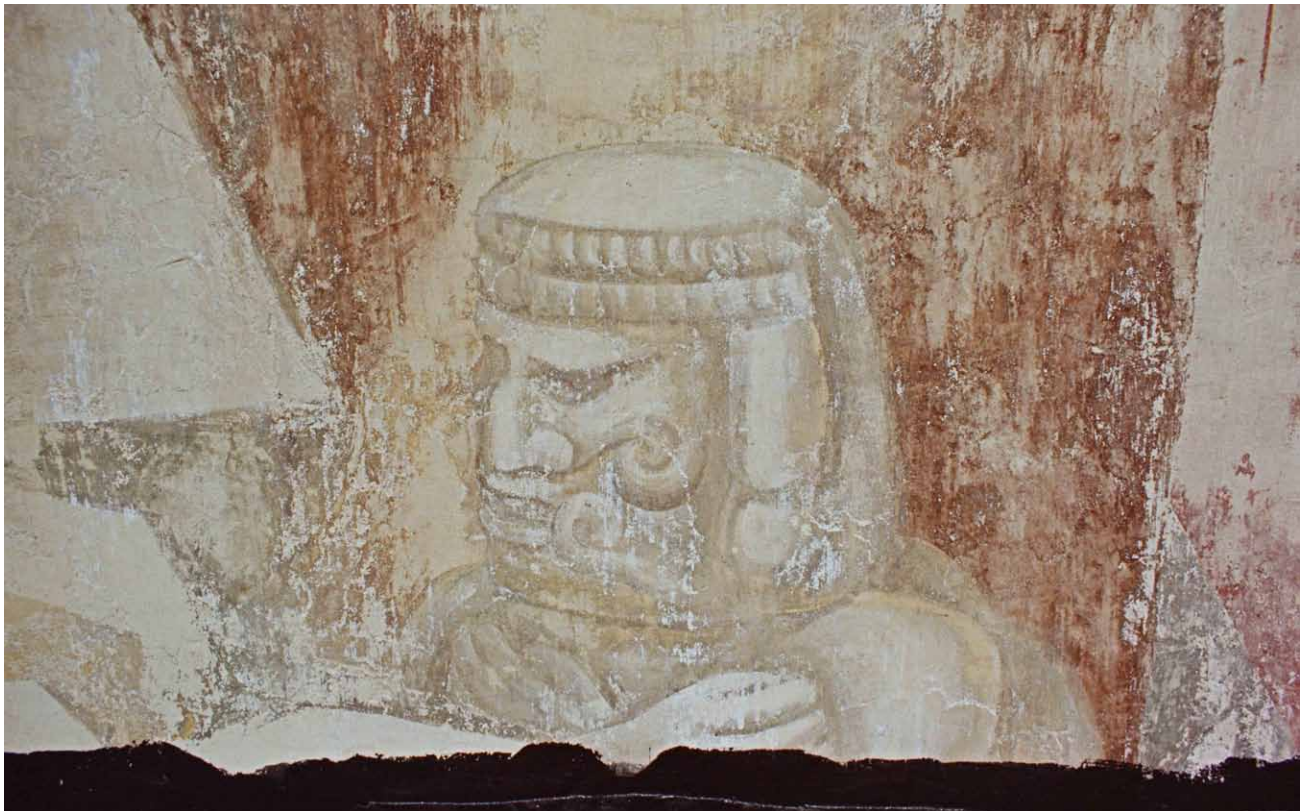
**Figure 2** Detail of the mural in 1971, showing the tar coating on the lower portion. Photo: Jesús Salvador Treviño; mural: © 2012, Artists Rights Society (ARS), New York/Sociedad Mexicana de Autores de las Artes Plásticas (SOMAAP), Mexico City

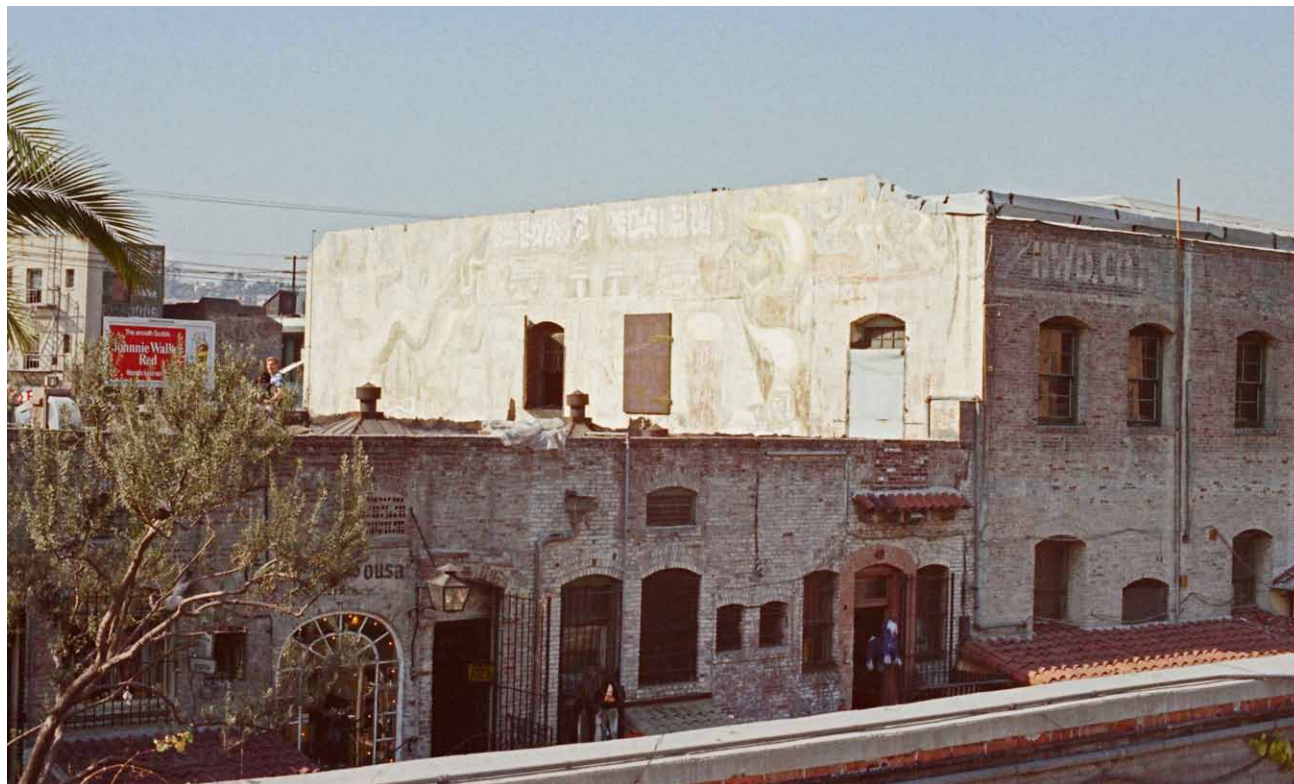
**Figure 3** The *América Tropical* mural seen from Olvera Street in March 1971, shortly after the February 1971 earthquake. Photo: Jesús Salvador Treviño; mural: © 2012, Artists Rights Society (ARS), New York/Sociedad Mexicana de Autores de las Artes Plásticas (SOMAAP), Mexico City

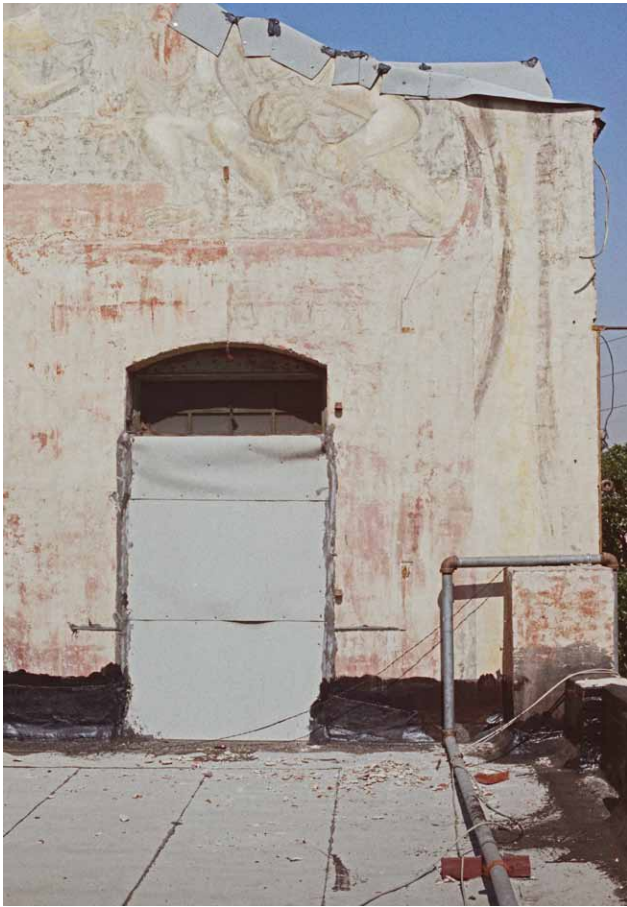
**Figure 5** Detail of the mural in 1971, showing the earthquake damage at the upper right corner. Photo: Jesús Salvador Treviño; mural: © 2012, Artists Rights Society (ARS), New York/Sociedad Mexicana de Autores de las Artes Plásticas (SOMAAP), Mexico City

When Mejía and Quezada inspected the mural, I filmed their analysis. They encountered a mural that had been damaged not just by time but by the earthquake that had hit Los Angeles in February of 1971 (fig. 5). It seems that Siqueiros had experimented with the new

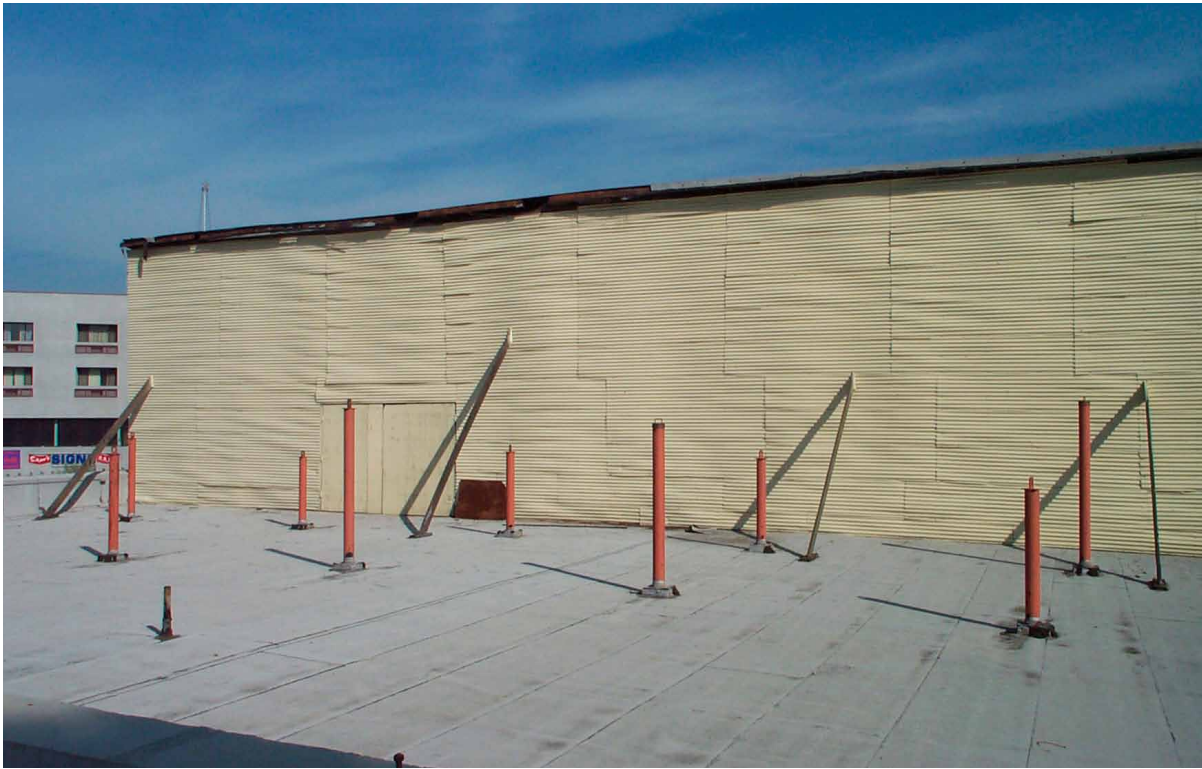
**Figure 1** One of a series of protective coverings erected over the mural since 1982. The steel columns in the foreground were intended to support a future mural shelter. Photo: Brooks + Scarpa

The Getty Conservation Institute (GCI), in collaboration with the City of Los Angeles and other interested parties, began in the 1990s to analyze the mural's condition and investigate various methods of protecting it and presenting it to the public. In 1996, as part of the mandatory seismic rehabilitation of unreinforced masonry buildings (known as Division 88), a project was undertaken to bring many of the El Pueblo de Los Angeles Historical Monument buildings up to code. As part of that project, columns were erected in the Hammel Building which projected through the roof in order to support a future mural shelter—one that had not yet been fully designed or funded (fig. 1).

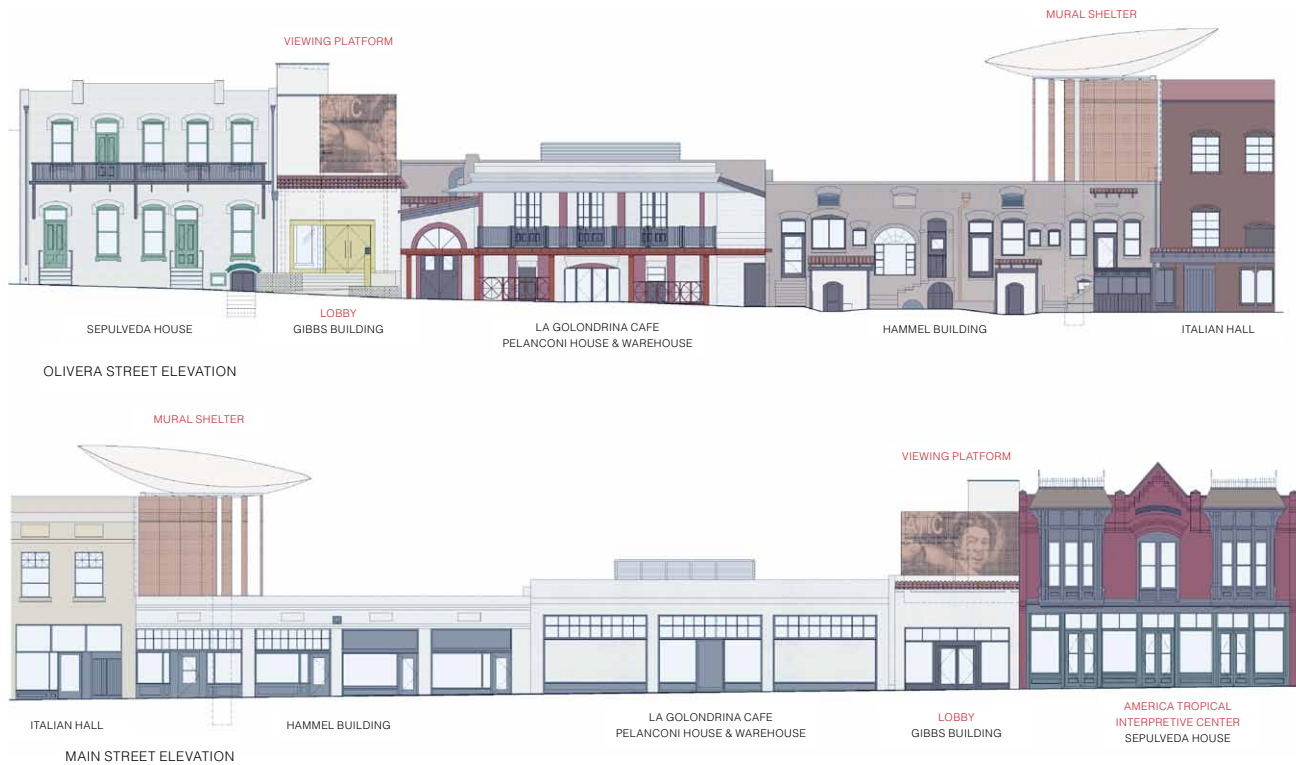
**Figure 3** Street elevations of the proposed mural shelter and viewing platform in the context of the buildings included within the project scope. Drawings: Brooks + Scarpa

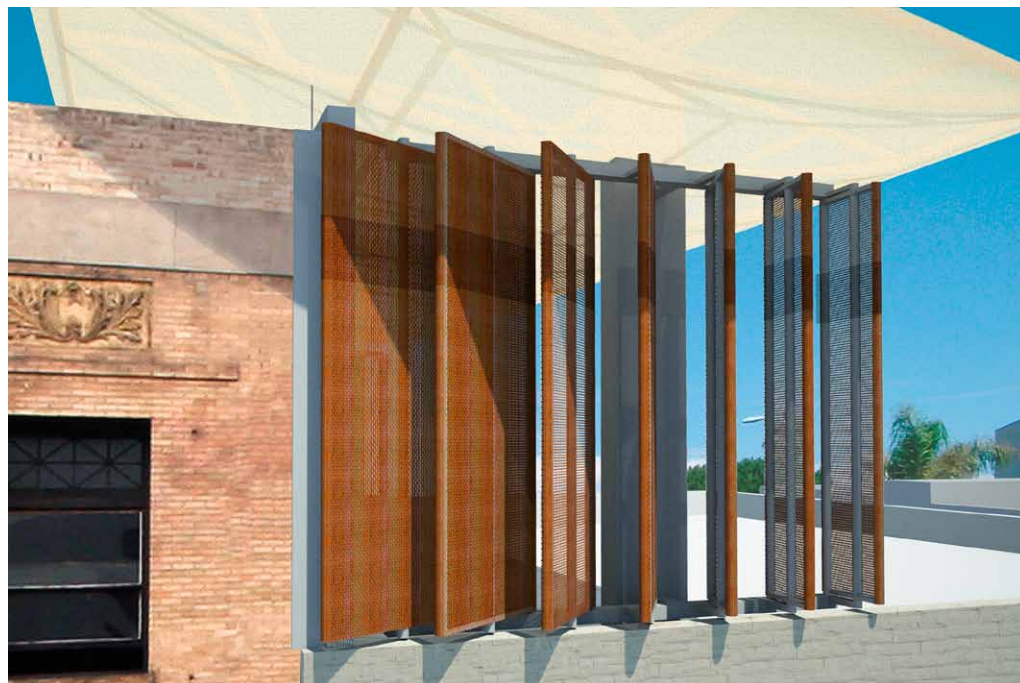
**Figure 7** Rendering of the mural shelter with sun-shades. Drawing: Brooks + Scarpa

The resolution of these issues came from the decision to eliminate the double column and transverse beam configuration below the roof surface. Instead, a single built-up column measuring eighteen by thirty-six inches was proposed at each end from foundation

to space frame, seismically isolated from the Hammel roof structure. The column line was moved away from the mural wall approximately fourteen feet (fig. 7), and an alternate type of roll-down screen was proposed that utilized a motor within the roll-tube itself. In order to more equally balance the forces acting through the space-frame-to-column connection, the shelter's size was increased east and west of the parapet edges. The

space frame profile was also tapered toward the edges in order to visually reduce the apparent mass, including a “knife-edge” continuous gutter at the perimeter. The easternmost column-to-pile-cap connection also required a wishbone-shaped, concrete-filled transverse beam that cantilevered over the Zanja Madre.

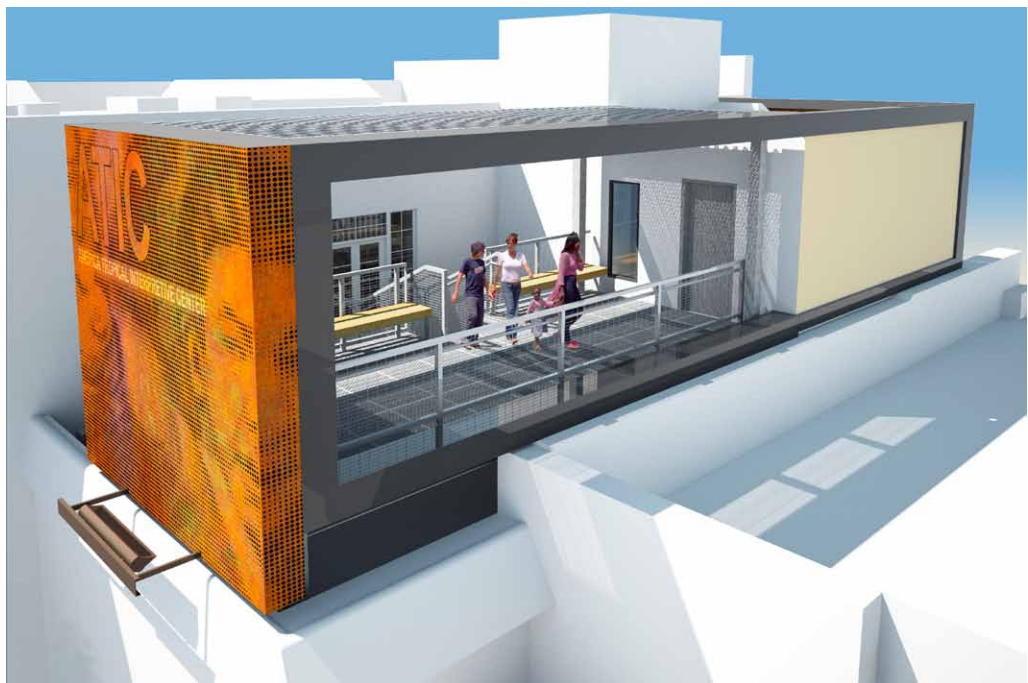
**Figure 8** Rendering of the viewing platform. Drawing: Brooks + Scarpa

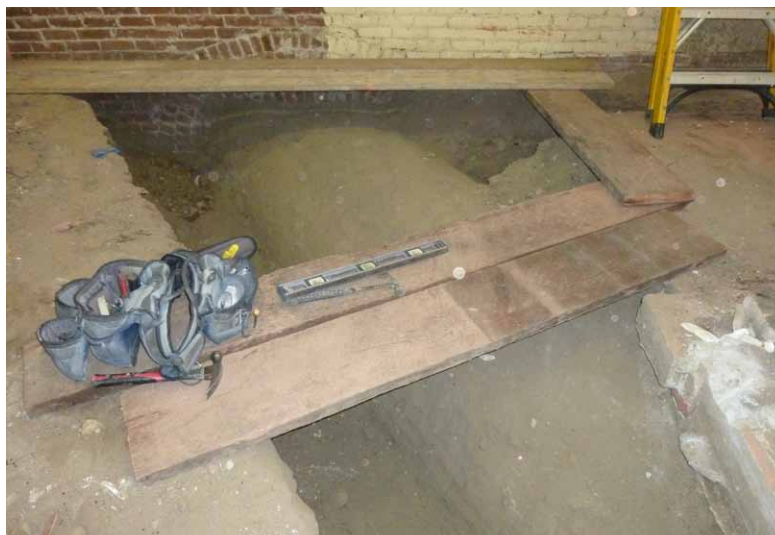
**Figure 3** The Zanja Madre exposed during construction. Photo: City of Los Angeles

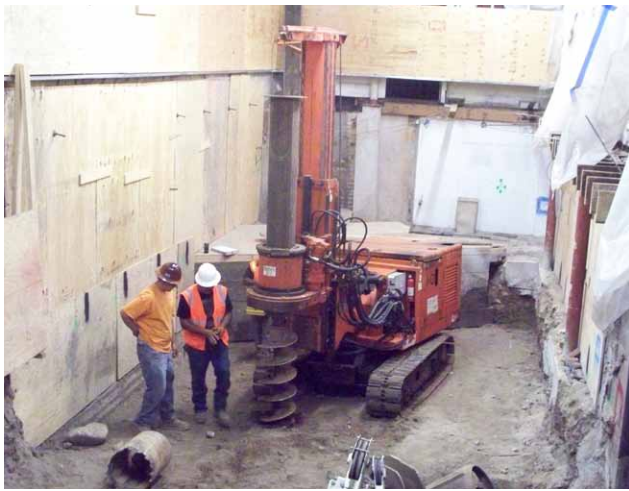
**Figure 5** Pile drilling in a confined space inside the Hammel Building. Photo: City of Los Angeles

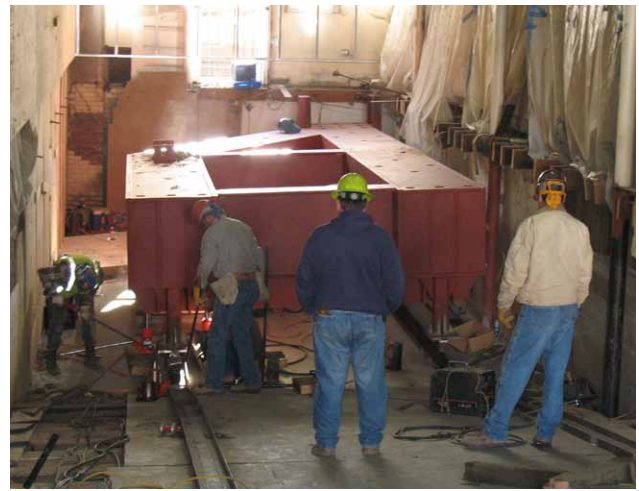
**Figure 6** The transfer beam in its final position. Photo: City of Los Angeles

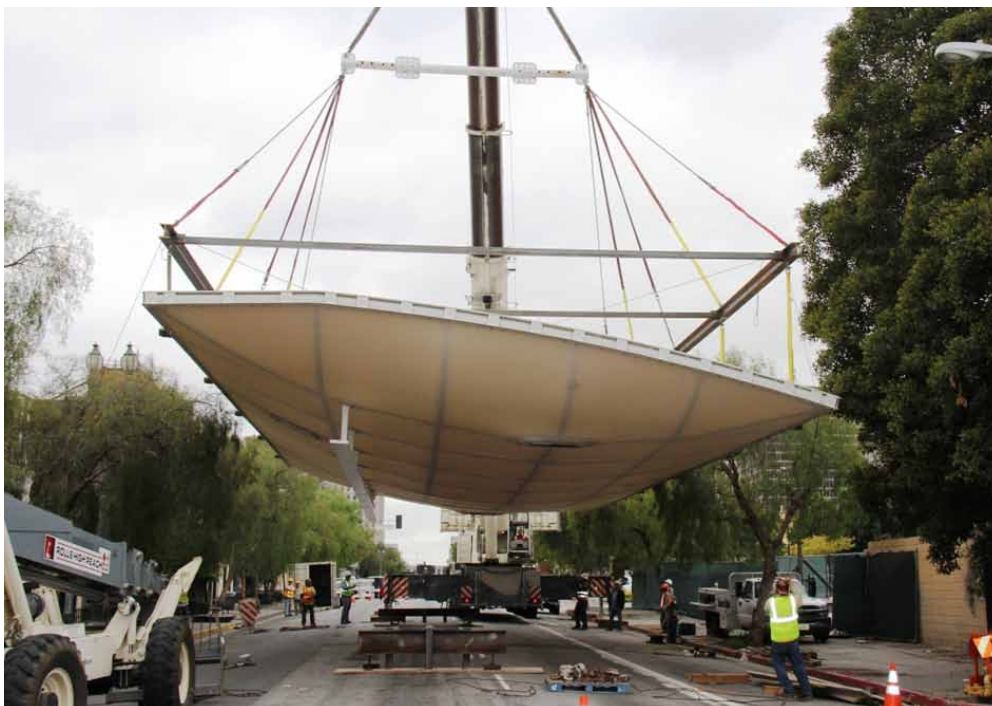
**Figure 9** Spectators watching as the crane lifts the canopy from the parking lot to Main Street. Photo: City of Los Angeles

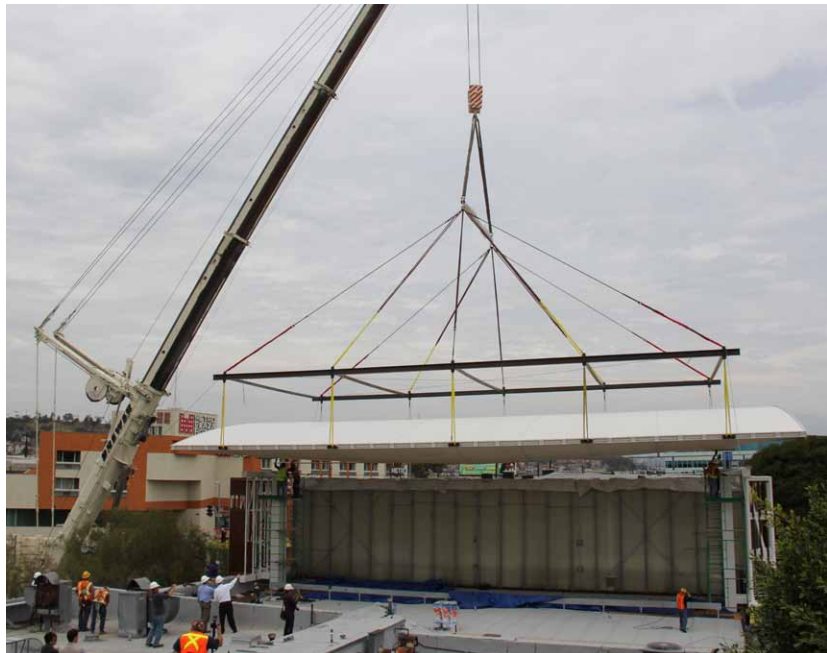
**Figure 10** The crane positioning the canopy on top of the columns above the roof of the Hammel Building. Photo: City of Los Angeles; mural: © 2012, Artists Rights Society (ARS), New York/Sociedad Mexicana de Autores de las Artes Plásticas (SOMAAP), Mexico City

to its two supports, which had previously been installed (fig. 10). As the canopy was lowered and guided onto its bolting plates, applause and cheers were heard throughout El Pueblo. The advance planning to ensure that the bolts lined up paid off: the installation went according to plan, the canopy was successfully installed over the mural (fig. 11), and on the third day, the street was reopened as scheduled.

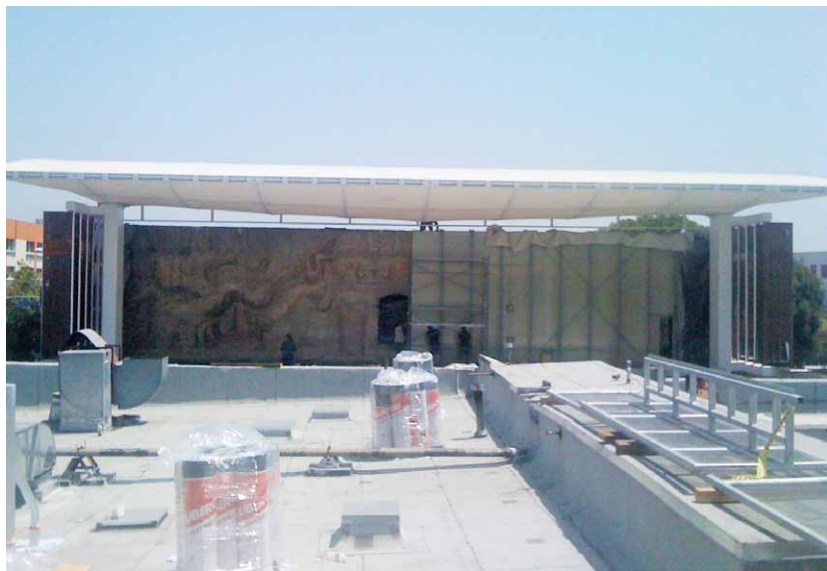
**Figure 11** The canopy after installation. Photo: City of Los Angeles; mural: © 2012, Artists Rights Society (ARS), New York/Sociedad Mexicana de Autores de las Artes Plásticas (SOMAAP), Mexico City

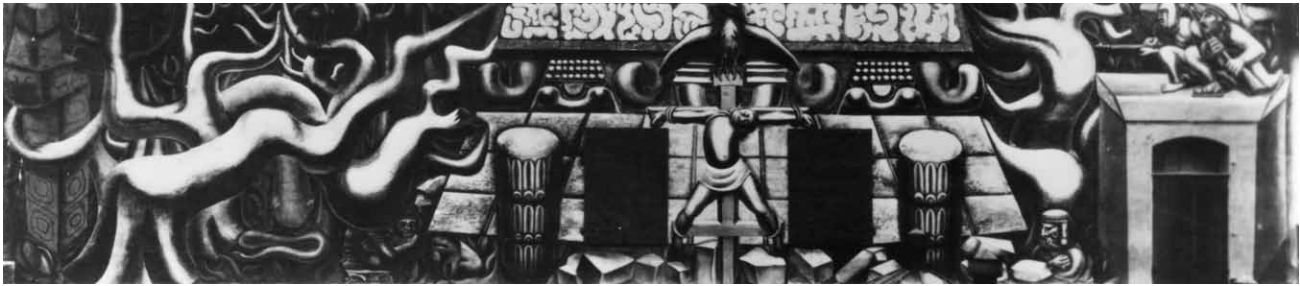
**Figure 1** Black-and-white photograph of the mural when it was first painted. Photo: John Weiskall, courtesy of El Pueblo Historical Monument; mural: © 2012, Artists Rights Society (ARS), New York/Sociedad Mexicana de Autores de las Artes Plásticas (SOMAAP), Mexico City

The mural, which measured approximately eighteen by eighty-two feet, depicted the artist's vision of tropical America—a central Indian figure lashed to a double cross with an eagle perched above him. The scene was set against the backdrop of a Mayan pyramid surrounded by an overgrown jungle, and in the upper right corner of the mural, two revolutionaries took aim at the eagle. Two preexisting shutters and a door were incorporated into the composition (fig. 1).

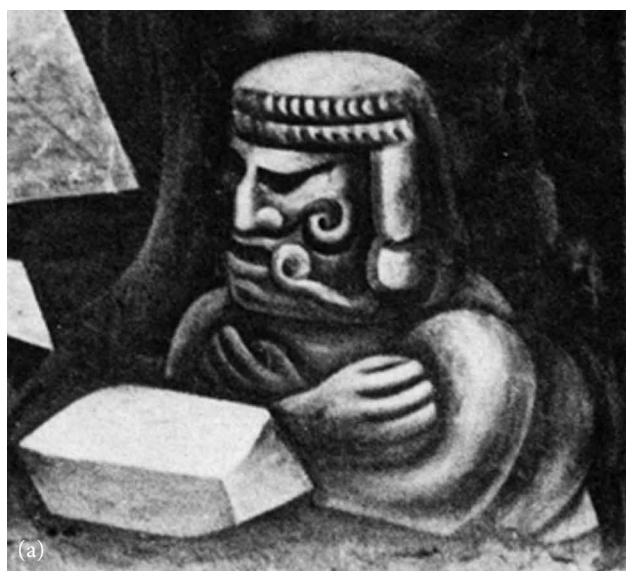
**Figures 5a and 5b** Detail of a sculpturally modeled head on the east end of the mural in a photograph from 1932 (a), and a current photo, from 2012 (b). Note the modeling of details, which is largely missing on much of the rest of the mural due to overall degradation of the surface. Photos: 5a: IQ Magic; 5b: J. Paul Getty Trust; 5a and 5b: mural: © 2012, Artists Rights Society (ARS), New York/Sociedad Mexicana de Autores de las Artes Plásticas (SOMAAP), Mexico City

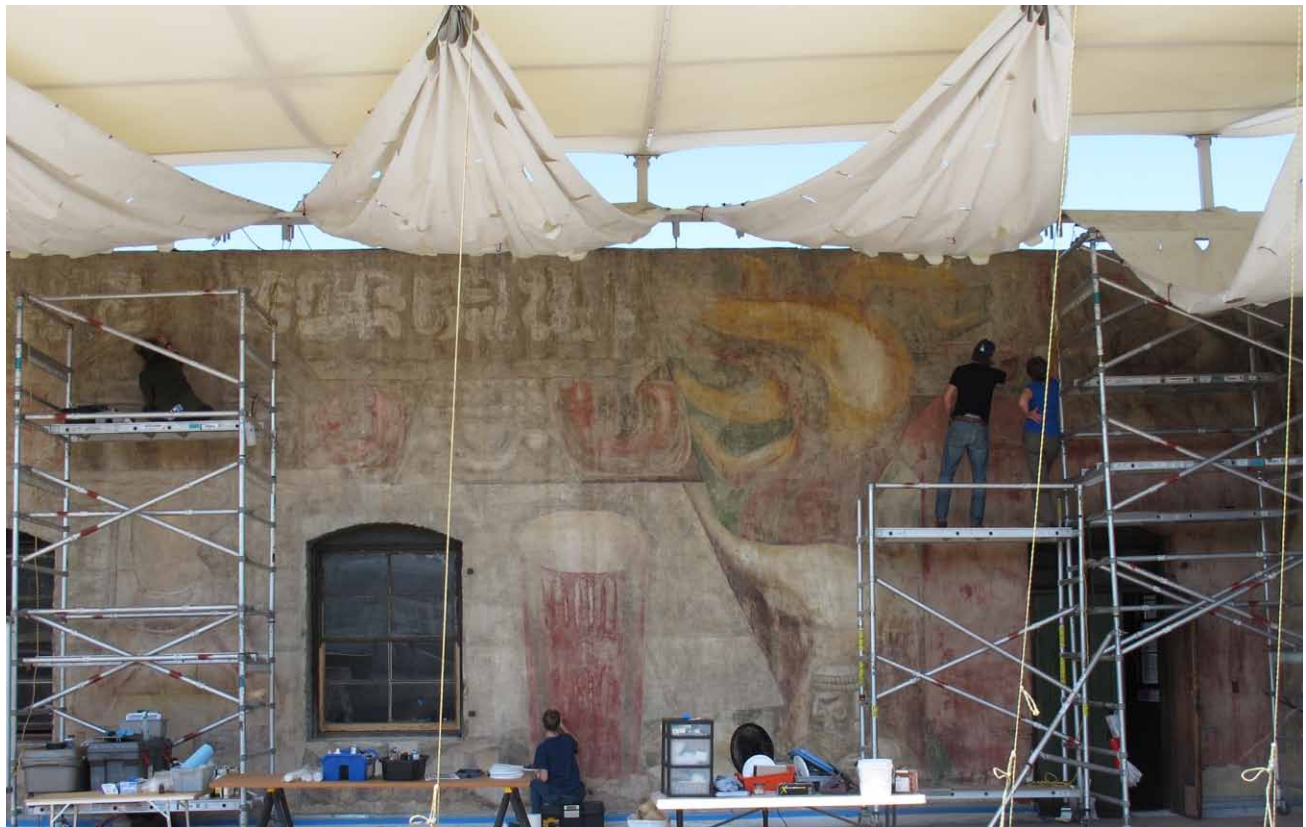
**Figure 6** The conservation team carrying out the final phase of treatment in 2012. Photo: J. Paul Getty Trust; mural: © 2012, Artists Rights Society (ARS), New York/Sociedad Mexicana de Autores de las Artes Plásticas (SOMAAP), Mexico City

Most recently, the GCI carried out a final phase of treatment, led by the author of this paper, along with Emily MacDonald-Korth, and Aneta Zebala of Zebala and Partners (fig. 6). The aim of the conservation treatment was to stabilize the mural, improve its appearance through cleaning, stain and tar reduction and removal, and limited visual reintegration, while preserving the authenticity of the artwork, telling the story of its tumultuous past, and reviving the clarity of the iconography. The treatment steps were as follows.

Surface cleaning was carried out using an aqueous system, and areas of heavier soiling were cleaned with an ammonium citrate solution. Localized areas of tar and residual tar stains and other types of stains were reduced and removed where possible, with solvents. Following surface cleaning and stain removal or reduction, and prior to inpainting, the surface was consolidated and resaturated with an isolating layer consisting of a dilute (less than 7%) solution of isobutyl and n-butyl methacrylate with ultraviolet light stabilizers in solvent.

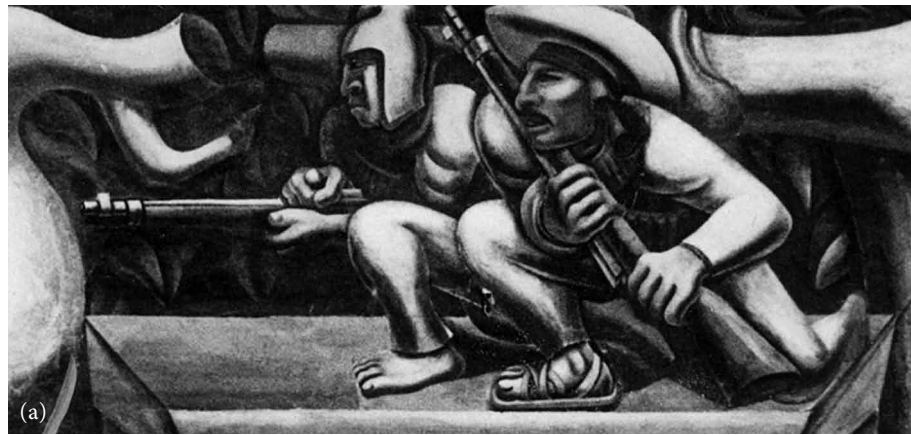
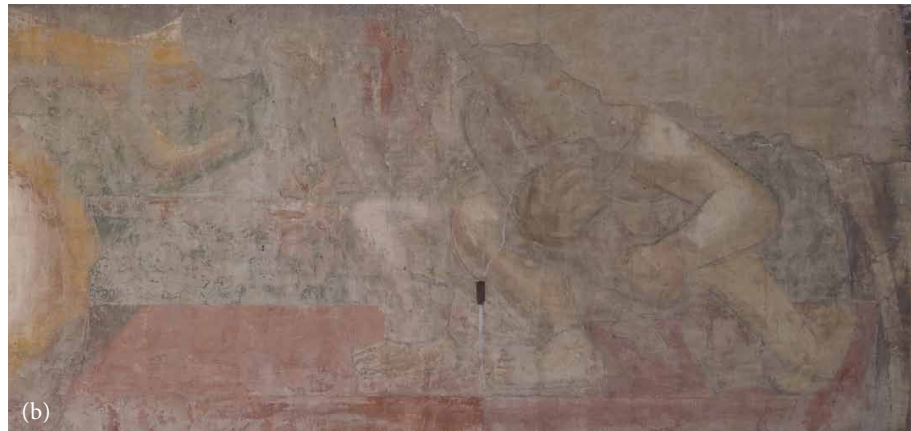
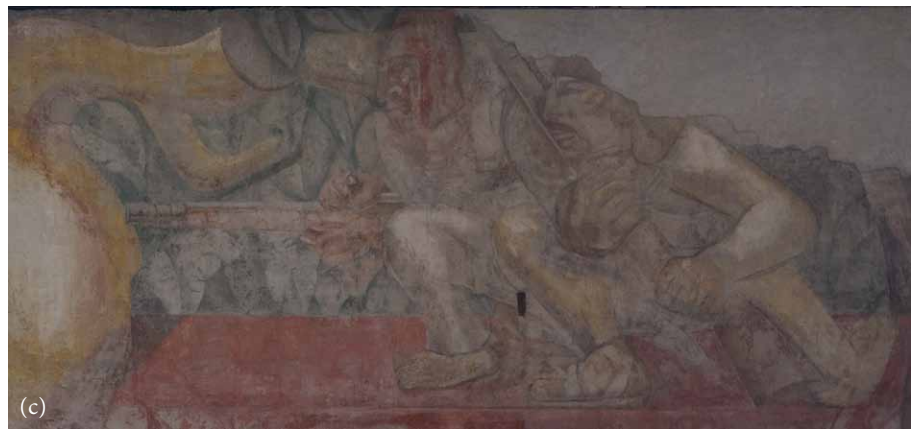
**Figures 7a–7c** Detail of the armed revolutionaries when the mural was first painted in 1932 (a), before the recent final phase of treatment (b), and after treatment in 2012 (c). Inpainting aimed to eliminate scratches and abrasions and reinstate the legibility of the image while preserving the integrity of the artist's hand. Photos: 7a: John Weiskall, courtesy of El Pueblo Historical Monument; 7b and 7c: J. Paul Getty Trust; 7a–7c: mural: © 2012, Artists Rights Society (ARS), New York/Sociedad Mexicana de Autores de las Artes Plásticas (SOMAAP), Mexico City

Visual reintegration, or inpainting, of the mural was done with artists' matte fluid acrylic colors over the isolating layer. Visual reintegration addressed areas of mechanical damage and clear abrasions, such as scratches and scrapes over much of the surface, and was performed on fills and other areas of past treatment, to match the surrounding area of original paint. Additionally, the reintegration reinstated legibility to the mural and reinforced forms by connecting isolated

areas of original paint, to bring back the continuity of the composition and its iconography, while preserving the artistic integrity of the artist's hand and the traces of history that the mural exhibited after suffering eighty years of censorship, neglect, and exposure (figs. 7a–7c).

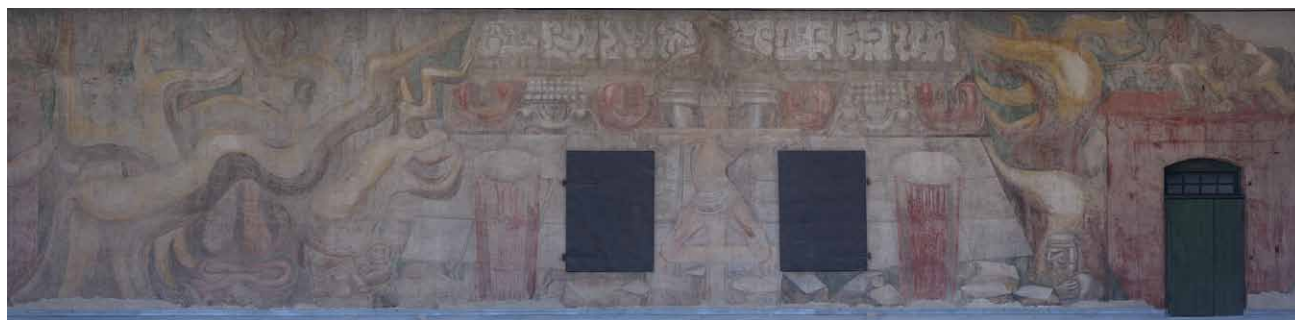
**Figure 8** *América Tropical* after treatment. Photo: Stacey Rain Strickler; mural: © 2012, Artists Rights Society (ARS), New York/Sociedad Mexicana de Autores de las Artes Plásticas (SOMAAP), Mexico City

*Tropical* was not restored to its original appearance because doing so would have entailed repainting much of the entire surface of the mural and would have left little or no trace of the artist's hand or the history told by the wear on the wall. Furthermore, because there is no color documentation of the mural from the time of its completion, it is impossible to determine the accurate hues, intensity, or saturation of the palette. By using digital imaging software, conservators were able to use details from a high-resolution historic black-and-white composite image of the mural when it was first painted (Hartman 2013), overlaid with a current image of the same areas, to better locate forms and islands of original paint remaining on the surface. This information allowed conservators to subtly reinforce the imagery of the mural and to reinstate legibility (fig. 8).

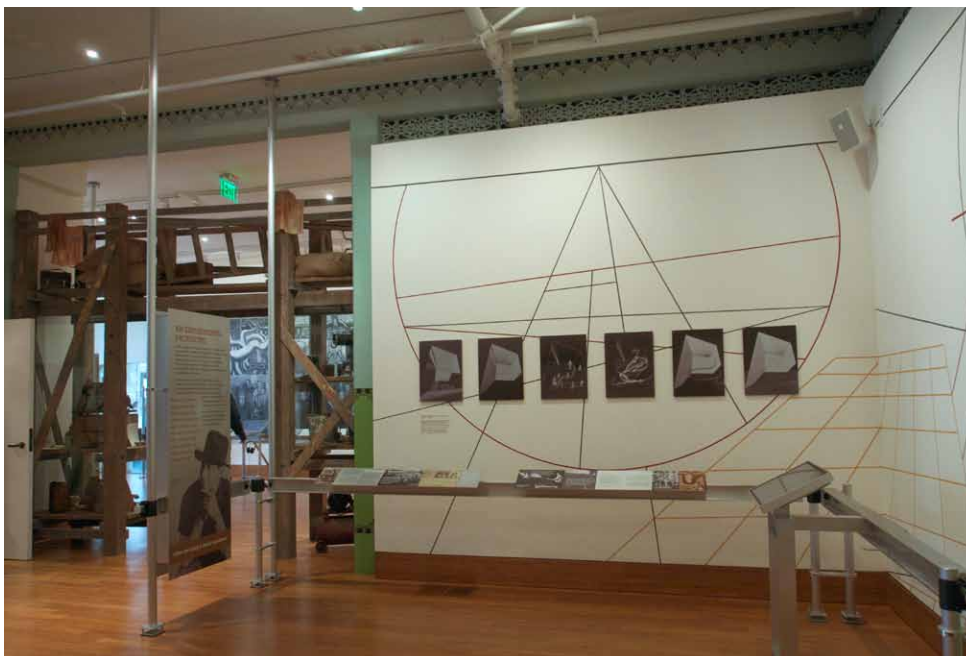
**Figure 3** The exhibit system is made up of vertical two-inch-diameter floor-to-ceiling support poles that distribute data and electrical from the floor into the system. Horizontal satin-finished aluminum I-beam members provide a wiring chase and support reader-rail graphics touchscreens and media equipment boxes. Photo: IQ Magic
