# **The Siqueiros Legacy: Challenges of Conserving the Artist's Monumental Murals**

Proceedings of a Symposium Organized by  
The Getty Conservation Institute

October 16–17, 2012

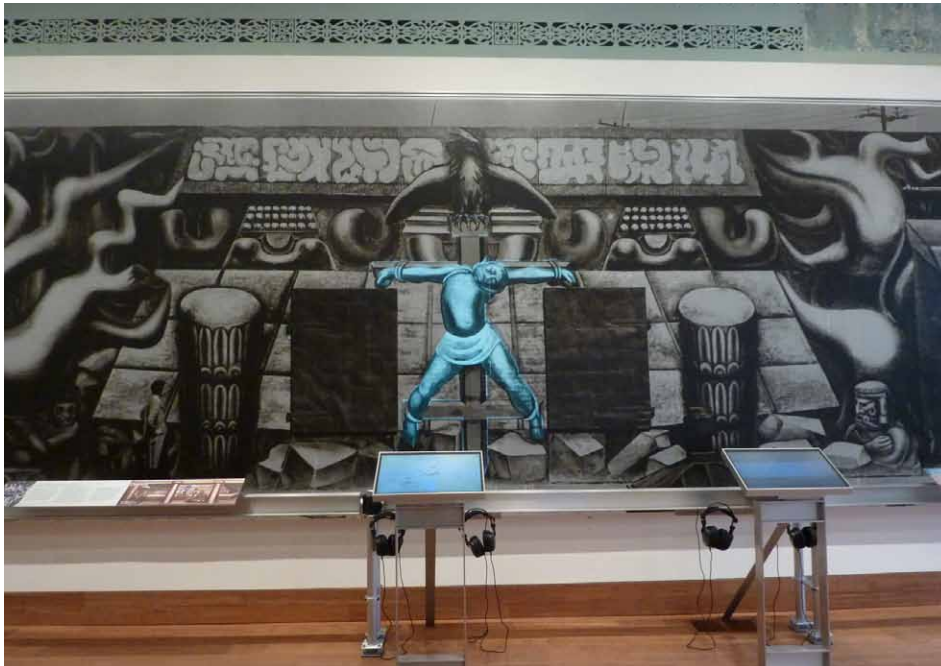
**Figure 6** A black-and-white mural, measuring eight by thirty-three feet, depicts *América Tropical*. The mural anchors the second gallery and is mounted over electroluminescent panels. Inverters and a controller are pulsed through touchscreens to infill illumination of the selected icons in the mural. As the icon begins its sequence, audio of Siqueiros's words describes his intent. Photo: IQ Magic; mural: © 2012, Artists Rights Society (ARS), New York/Sociedad Mexicana de Autores de las Artes Plásticas (SOMAAP), Mexico City

In the next gallery, a large black-and-white mural of *América Tropical*, measuring eight by thirty-three feet, is interactively activated through touchscreens that explain the iconography of the mural in images and Siqueiros's own words. The image was printed from a scan of a high-density composite image produced by IQM from four different image sources. No other single photograph found in any publication depicts the mural in its entirety (fig. 6).

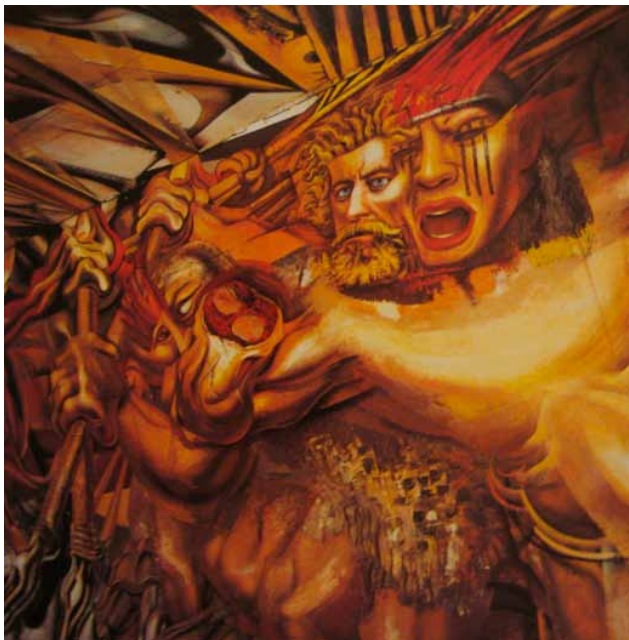
**Figura 3** Detalle *Muerte al invasor*. Escuela de México en Chillán, Chile. Foto: Taller de Obra Mural. CENCROPAM-INBA

localizada en el ex Sindicato Mexicano de Electricistas; “Muerte al invasor” (1941–1942) en la Escuela México en Chillán, Chile (Figura 2) (Figura 3); “Por una seguridad completa y para todos los mexicanos” (1952–1954) del Centro Médico la Raza del Instituto Mexicano del Seguro Social (Figura 4); “Maternidad” (Figura 5) y “Escuela para el Estado de México” (1965–1973) en la Sala de Arte Público Siqueiros (Figura 6); y la “Sala Poliangular” (1971–1973) en La Tallera en Cuernavaca. (Figura 7) (Figura 8)

La obra mural presentaba degradación del soporte, llegando a ser muy severa en áreas considerables, con suciedad acumulada, distorsión y separación de estratos; oxidación y debilitamiento del sistema de anclaje por efecto de la humedad.

áreas con pérdidas de superficie pictórica y numerosas intervenciones anteriores con alteraciones cromáticas. Se realizaron tareas de limpieza mecánica y química, en muros norte y sur, para posteriormente intervenir en el desanclaje de las planchas más deterioradas e intervenirlas en mesa de trabajo, en su anverso y reverso, pudiéndose trabajar las contiguas y el resto de las planchas, en su sitio original. Se revisó también el sistema de anclaje de las planchas en toda la superficie, sustituyendo los elementos oxidados.

En el caso de la capa pictórica se consolidaron previamente todas las áreas de agrietados y craquelado en forma de escamas, recuperando donde era necesario el plano original por medio de inyecciones de material adhesivo y plancha térmica, asegurando la capa pictórica de posibles pérdidas. Posteriormente se procedió a aplicar una pasta compatible en áreas de faltantes. Se eliminaron intervenciones anteriores y materiales ajenos por medio de una limpieza mecánica y química, localizada y específica hasta llegar a la reposición cromática.

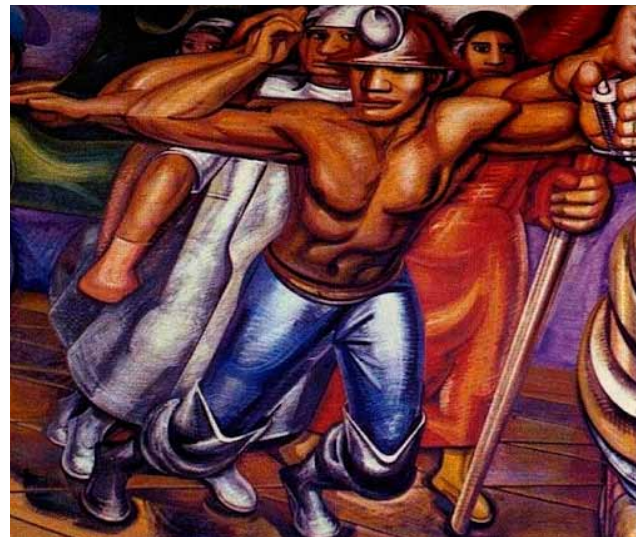
**Figura 4** Detalle *Por una seguridad completa y para todos los mexicanos*. Centro Médico La Raza del Instituto Mexicano del Seguro Social. México D.F. Foto: Taller de Obra Mural. CENCROPAM-INBA

Estas obras realizadas en espacios interiores registran daños comunes y recurrentes, que tienen su origen en la alteración y deformaciones de sus materiales de soporte, reflejándose en su superficie pictórica, en presencia de grietas, fisuras y pérdida de la capa de color.

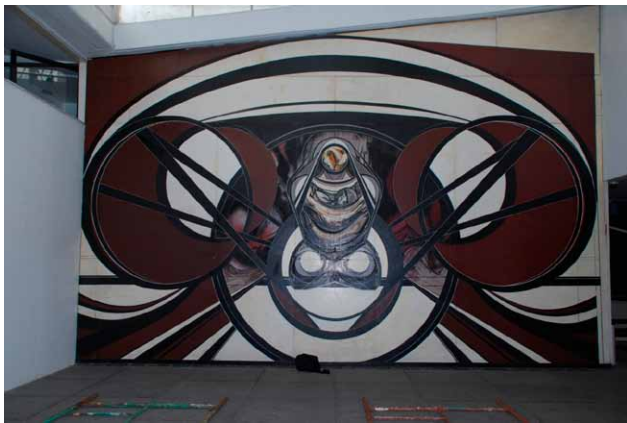
**Figura 5** *Maternidad*. Sala de Arte Público  
Siqueiros. México D.F. Foto: Taller de Obra Mural.  
CENCROPAM-INBA

En el caso del soporte, realizado en *celotex*, la naturaleza higroscópica del mismo y el contacto permanente con la humedad de la edificación generaron deterioros específicos: disgregación del material de soporte, proliferación de microorganismos, desfasamiento y deformación de paneles entre otros. A su vez al hincharse, producto del exceso de humedad, se acelera el tipo de deterioro facilitando la pérdida parcial de algunos elementos.

Por otro lado, la forma de almacenaje y manipulación de la obra de paneles desmontables que por un tiempo estuvieron almacenados en bodegas, fomentaron notables deterioros como deposición de suciedad en la superficie, manchas y gotas de distintos materiales. En algunos puntos de montaje, debido a la fricción y a la falta de cohesión de esas zonas, se han ocasionado desgarres y pérdidas del soporte, y por consiguiente de capa pictórica, volviéndose en algunos casos, zonas de peligro de desprendimiento de original.

1. Fumigación. Con el objetivo de eliminar el bio-deterioro del soporte, huevo, larva o insecto, se realiza una fumigación por medio de cámara cerrada y un agente piretroide a base de permetrina.
2. Limpieza. Se elimina el polvo y la suciedad adheridos a la obra.
  - Mecánica: La eliminación del polvo en la superficie se propone hacerla en anverso y reverso, con la ayuda de una brocha de pelo suave.
  - Química: La eliminación de restos de manchas y mugre se realiza con la ayuda de un tensoactivo y de espuma de jabón quirúrgico

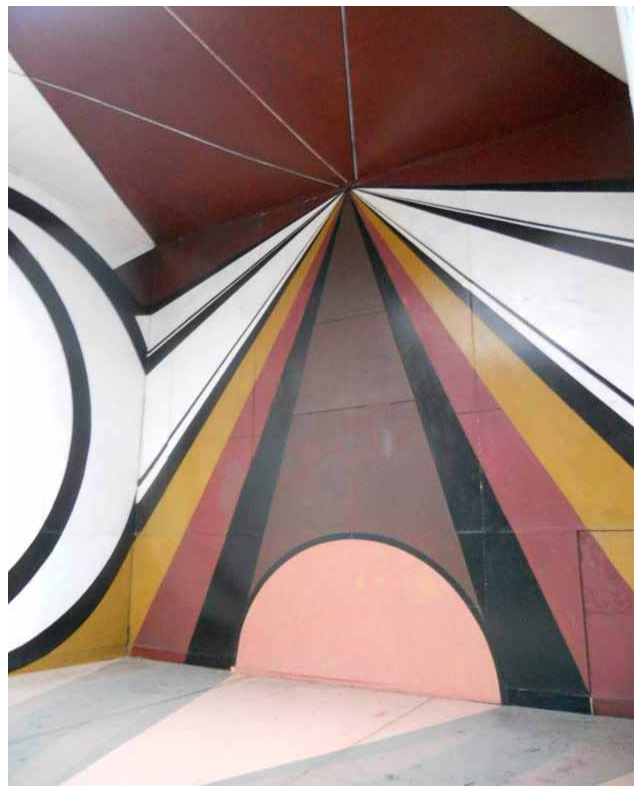
**Figura 7** Vista Sala Poliangular. La Tallera. Cuernavaca,  
Estado de Morelos. Foto: Gabriela Gil

La “Sala Poliangular” sufre de los mismos factores de deterioro que los murales que se encuentran en la SAPS.

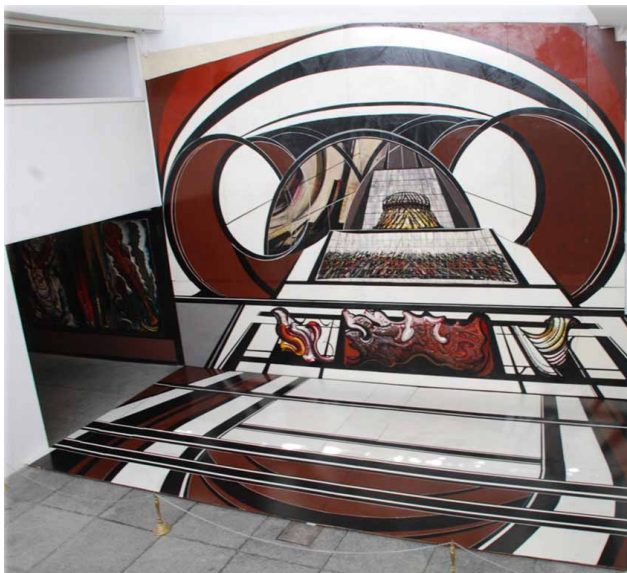
**Figura 6** *Mural para una Escuela del Estado de México*.  
Sala de Arte Público Siqueiros. México D.F. Foto: Taller  
de Obra Mural. CENCROPAM-INBA

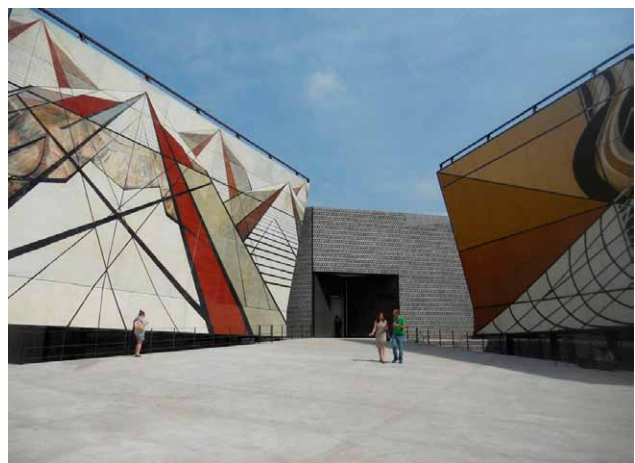
**Figura 8** Detalle Sala Poliangular. La Tallera.  
Cuernavaca, Estado de Morelos. Foto: Gabriela Gil

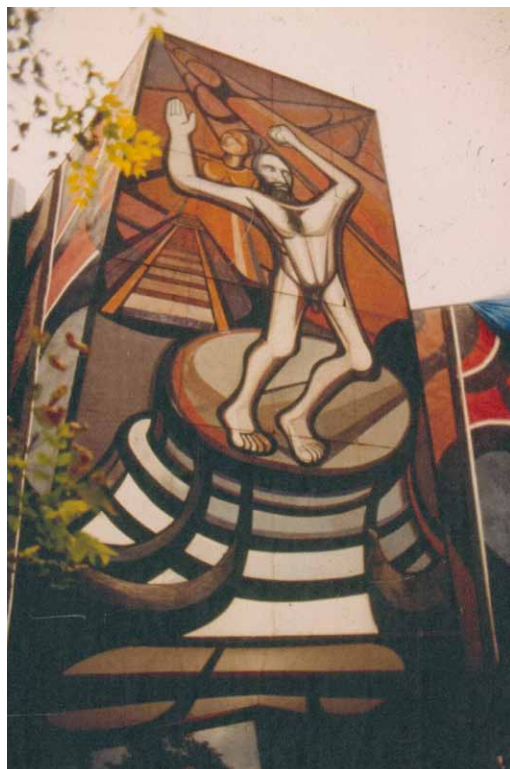
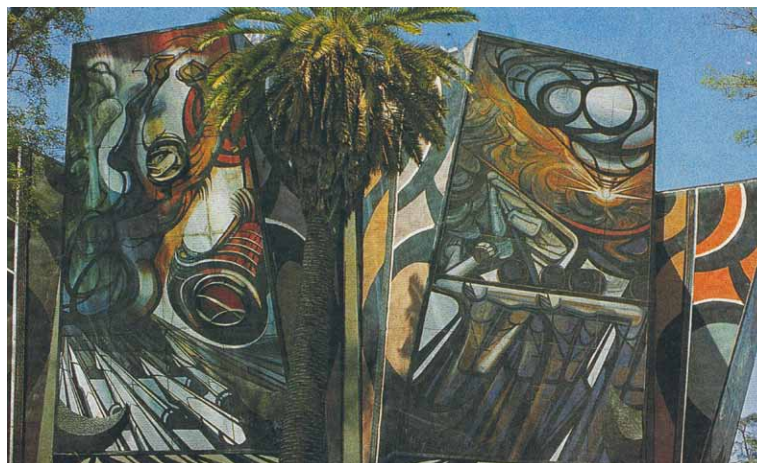
**Figuras 1a y 1b** Exterior del Poliforum mostrando paneles murales. Foto: Grupo de Restauradores para el Poliforum, 1995

En los cinco casos que hemos podido observar, existe una muy buena adherencia de la capa pictórica acrílica con la superficie del asbesto-cemento. Sin embargo, las placas de asbesto-cemento se deforman y se fracturan fácilmente. ¿Qué tan fácilmente? No lo hemos medido aún, pero podemos ejemplificarlo.

Estamos hablando de placas elaboradas con asbesto de fibra corta. Sus dimensiones varían de  $3.56 \times 1.78$  metros a  $4.10 \times 2.24$  metros y su espesor de 1.5 a 2 centímetros. Las placas están atornilladas a un emparrillado de ángulos de hierro, el cual su vez, está soldado a la estructura metálica de las salientes trapezoidales que arman a cada uno de los murales exteriores. Los tornillos de sujeción tienen un patrón de distribución promedio de 0.50 metros cuadrados, es decir, cada tornillo sujeta un área de 0.50 metros cuadrados de la placa. En los casos en los que faltaban los dos tornillos más cercanos a

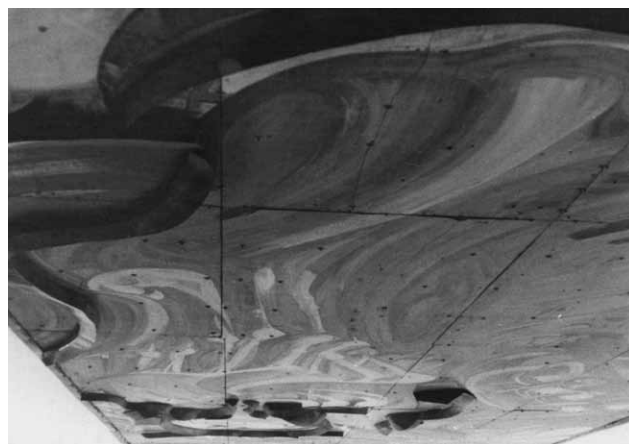
**Figura 4** Grietas y roturas en las laminas de asbesto-cemento. Véase como se alinea la grieta con los tornillos de fijación. Abajo y a la izquierda se observan las aplicaciones metálicas. Foto: Grupo de Restauradores para el Poliforum, 1995

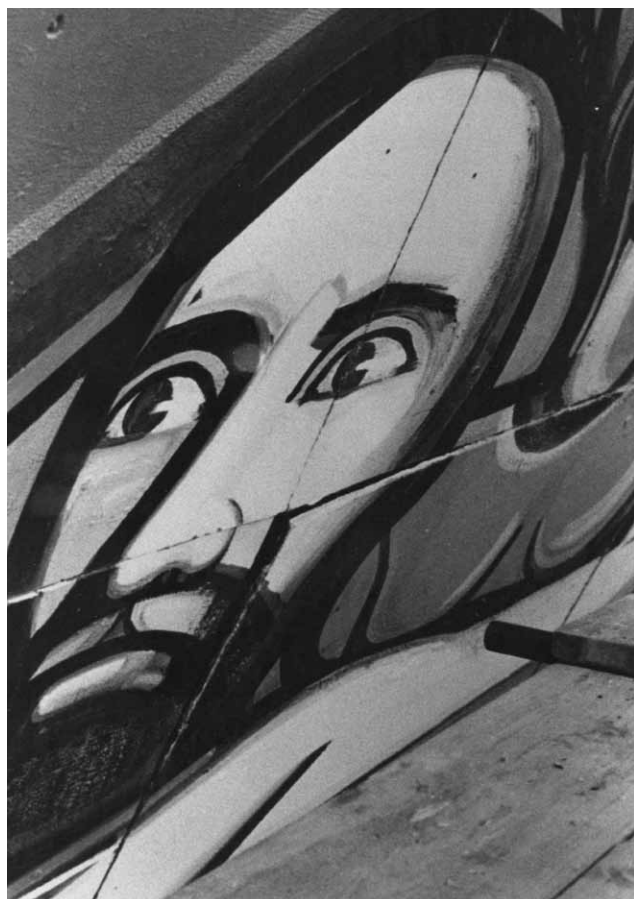
**Figura 5** Deformación en la esquina de la línea causada por tensiones diferenciales. Foto: Grupo de Restauradores para el Poliforum, 1995

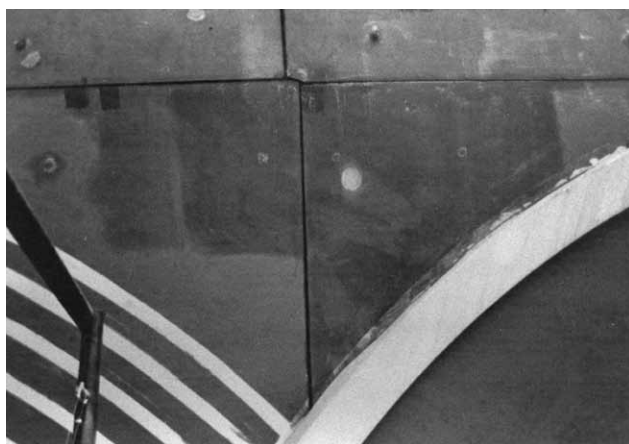
**Figura 7** Pruebas de eliminación del velo blanquecino. Huellas de los tornillos de fijación. A la derecha aplicación metálica. Foto: Grupo de Restauradores para el Poliforum, 1995

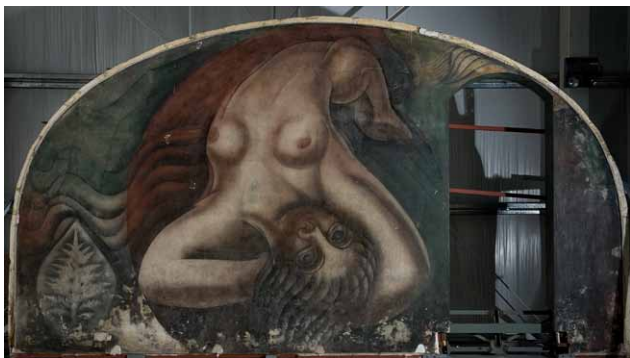
**Figura 4** Tímpano anterior, antes de la restauración.

Un interesante testimonio de Juan Carlos Castagnino, fechado en 1962, da cuenta de la técnica de ejecución: “En cuanto al trazado armónico del conjunto, (Siqueiros) comenzó por analizar cada muro en particular, en forma autónoma. Terminada esta operación procedió a establecer las correlaciones espaciales tirando cordeles o empleando largas reglas flexibles para relacionar dos puntos armónicos situados en planos distintos o en el plano del muro y curva de la bóveda, o en el punto de encuentro de muro y piso. Los ritmos generales de ubicación se trazaron con tinta oscura sobre el gris del cemento grueso. Luego, las correcciones que surgían al llevar las imágenes con el proyector eléctrico se destacaban con líneas blancas. Se tomaban fotografías de los resultados parciales y finales, y con estas últimas se trabajaba sobre el revoque definitivo realizado con una mezcla de cemento portland y marmolina. Previamente se humedecía el muro a fondo. Recién entonces se aplicaban los colores de pigmentos utilizándose un aerógrafo, ya que el fraguado rápido del revoque de cemento no daba tiempo, sobre todo en los tonos intensos y oscuros, que debieron ser tratados al final con colores al silicato”. (Castagnino, 1962)

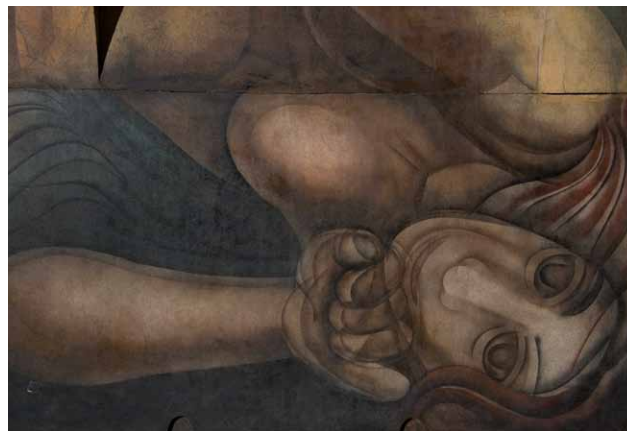
**Figura 5** Detalle de la pared izquierda, después de la restauración. Foto: Gustavo Lowry

Interpretamos entonces que los retoques al silicato sobre el fresco ya fraguado, se habrían hecho en “húmedo” y no *a secco*.

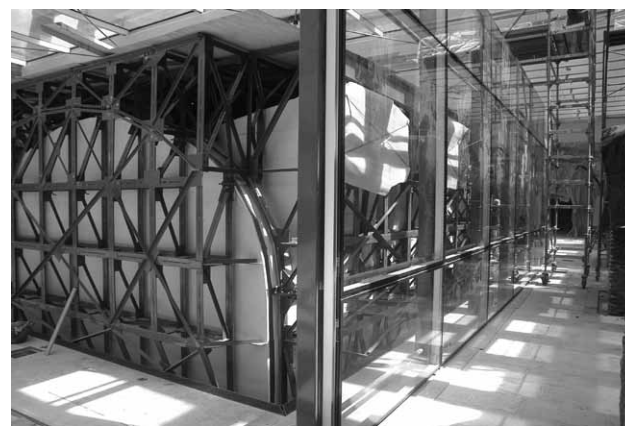
**Figura 7** Instalación del mural en un recinto de vidrio en el Museo del Bicentenario. Foto: Néstor Barrio

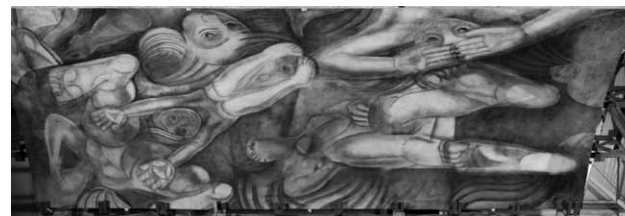
**Figura 8** La bóveda de *Ejercicio Plástico* después de la restauración. Foto: Gustavo Lowry

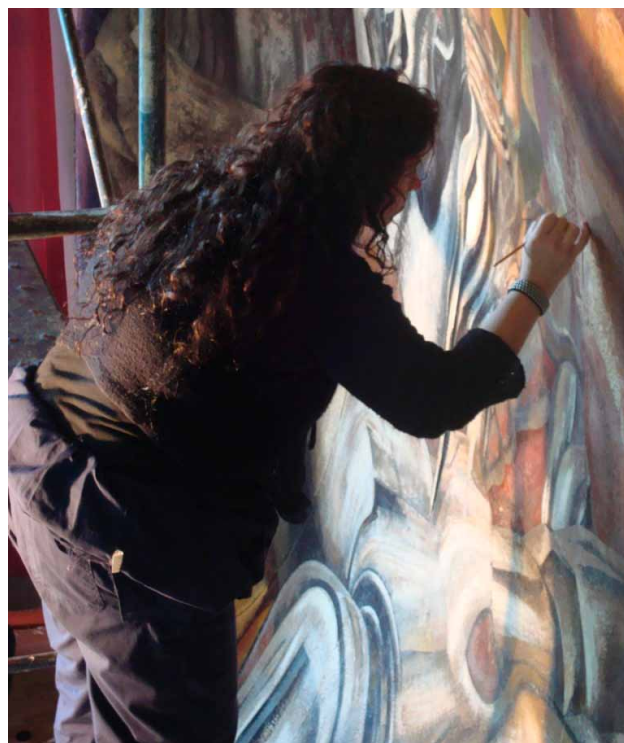
**Figura 5** *Muerte al invasor* de David Alfaro Siqueiros. Mónica Pérez, restauradora chilena durante la restauración realizada en el año 2009. Foto: Ossa. 2010

En agosto del año 2008 se da inicio a una nueva restauración, esta vez con un equipo formado por restauradores mexicanos y chilenos, coordinados por un restaurador del Centro Nacional de Conservación y Registro del Patrimonio Artístico Mueble del Instituto Nacional de Bellas Artes de México (CENCROPAM-INBA). El proyecto fue financiado por el Fondo Conjunto de Cooperación Chile-México, fruto de un acuerdo de cooperación entre el Estado Mexicano y Chile. (Figura 5)

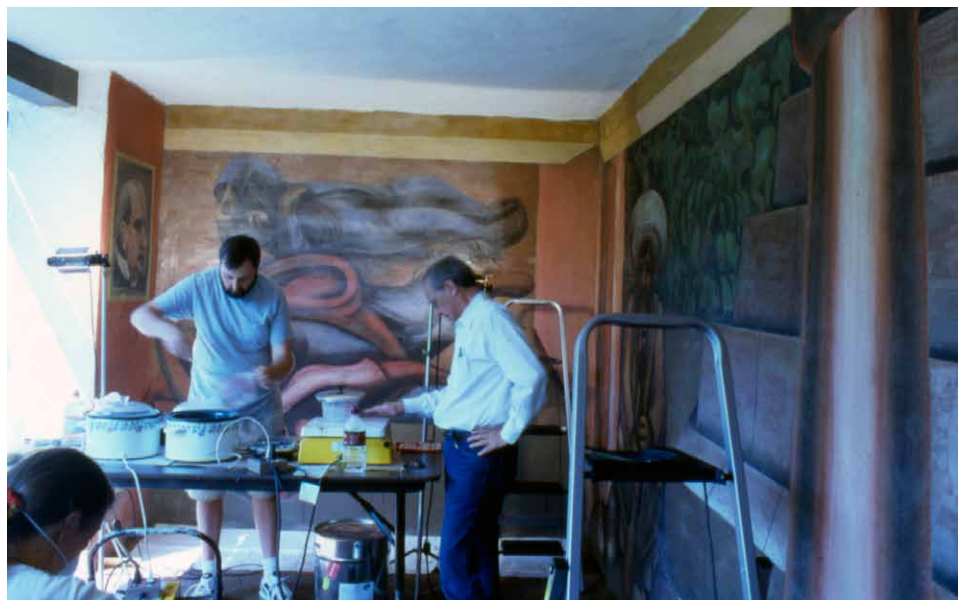
**Figure 4** Gary McGowen applying a layer of gauze between the second and third layers of the cyclododecane facing, for added strength and protection of the mural in its move to Santa Barbara. Photo: Siqueiros Mural Project Team, Courtesy Santa Barbara Museum of Art; mural: © 2012, Artists Rights Society (ARS), New York/Sociedad Mexicana de Autores de las Artes Plásticas (SOMAAP), Mexico City

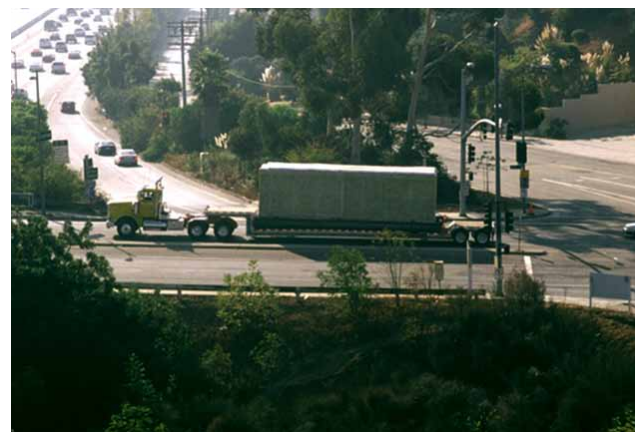
**Figure 6** *Portrait of Mexico Today* traveling on the Sunset Boulevard overpass of the 405 Freeway in Los Angeles, en route to Santa Barbara. Photo: Siqueiros Mural Project Team, Courtesy Santa Barbara Museum of Art

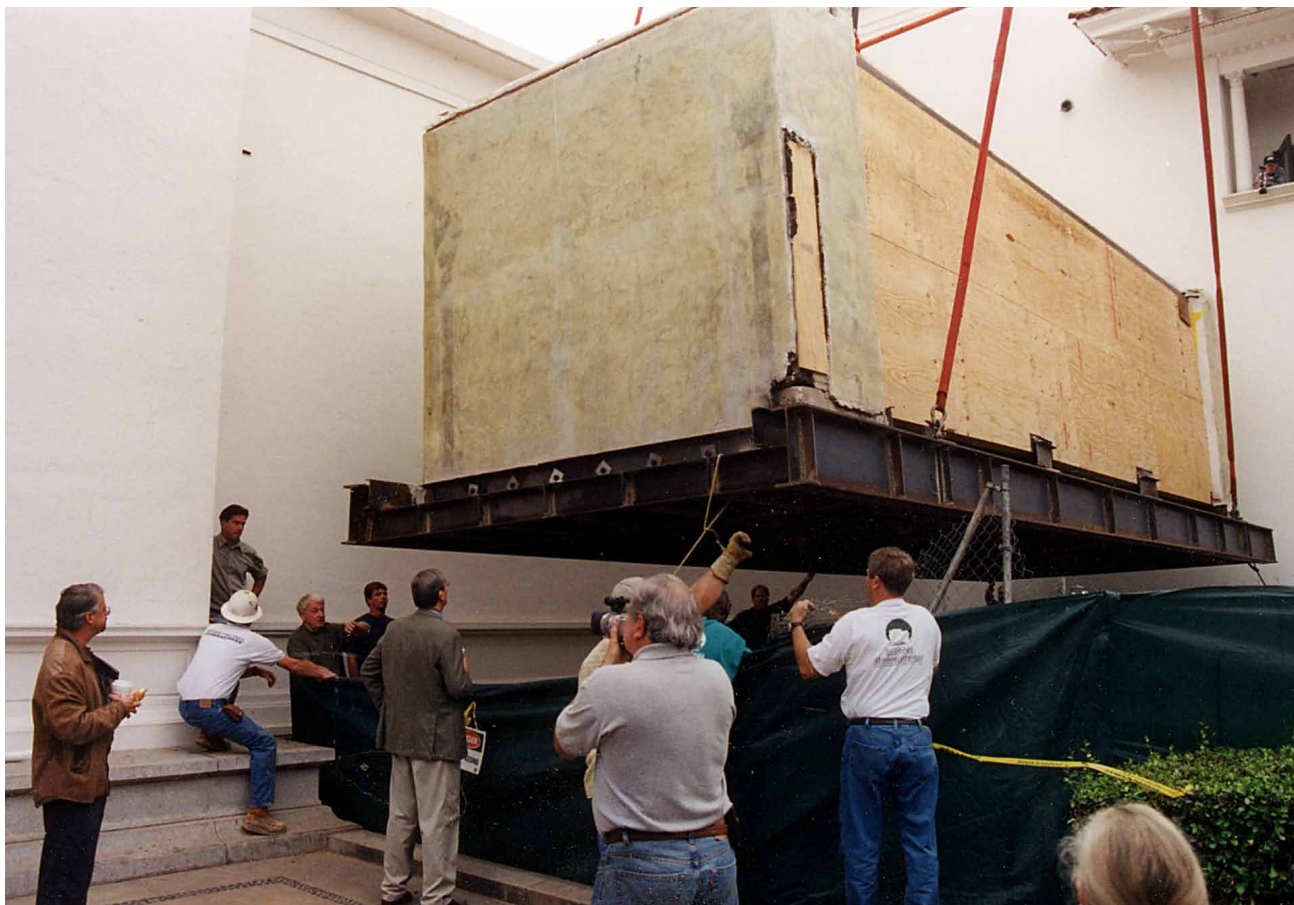
**Figure 7** Crane operators and general contracting team members, placing the mural on its new foundation in Santa Barbara. John Sullivan is seen standing at the far back left corner; Ted Hollinger is immediately below him, facing forward; and Robert Frankel, seen from the rear, stands in the center. Photo: Siqueiros Mural Project Team, Courtesy Santa Barbara Museum of Art

lifted onto its new foundation, and the protective panels and plastic are immediately removed so that conservators can examine the artwork in detail (fig. 7). It is a jubilant moment when Huston exclaims, “We’ve done it! We have moved the mural to Santa Barbara without any visible damage to the artwork or its superstructure.”

The old and new foundations are then melded as a sand-concrete mix is filled in around the platform. Fresh

stucco is applied directly over the outermost layer of glass fabric, creating a sturdier exterior, and a new roof and cornices are installed to mimic the originals. Using the authentic bricks, the floor in front of the mural is reconfigured just as it had been in the Pacific Palisades home. At this point, the entire structure is secured and left for several months so that the cyclododecane can sublimate.

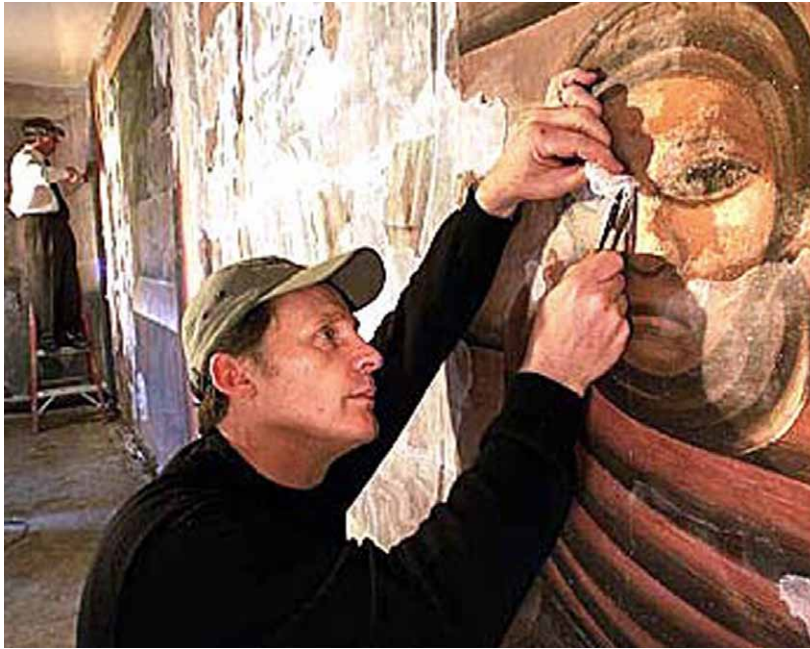
**Figure 8** Perry Huston (left) and Scott Haskins (right), removing the gauze layer of the cyclododecane facing applied to *Portrait of Mexico Today*. Photo: Siqueiros Mural Project Team, Courtesy Santa Barbara Museum of Art; mural: © 2012, Artists Rights Society (ARS), New York/Sociedad Mexicana de Autores de las Artes Plásticas (SOMAAP), Mexico City

Once the evaporation process is complete, conservators again hand-palpaté the walls and compare the findings against earlier palpations conducted by the team in Pacific Palisades prior to the move (fig. 8). It is determined that the existing delaminations had not increased in size or number as a result of transport. The move is considered a complete success. Previously identified separation pockets are wetted with alcohol and injected with Rhoplex AC33, thickened with Acrysol, by way of large hypodermic needles through small existing cracks in the wall or through small holes drilled into the painting's surface. The minuscule drill holes are filled and textured with a commercial and soluble filling material. The mural is then inpainted with watercolors and Golden Artist Colors, containing mineral-spirit-based acrylic (MSA) resin, which is soluble in xylene (fig. 9). Since applying an overall finish to the mural at this

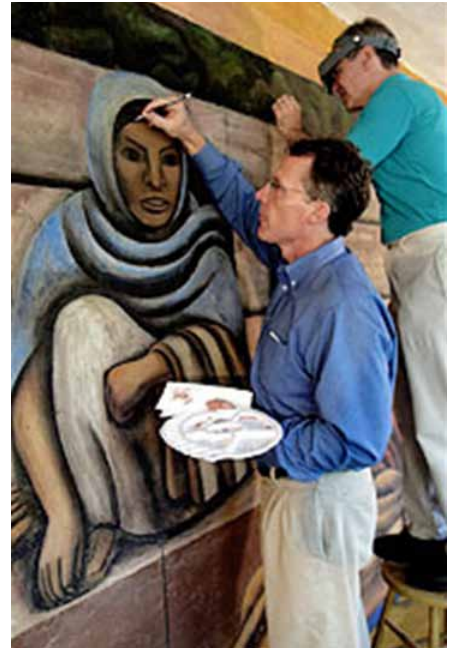
**Figure 9** Scott Haskins (left) and Perry Huston (right) inpainting *Portrait of Mexico Today*. Photo: Siqueiros Mural Project Team, Courtesy Santa Barbara Museum of Art; mural: © 2012, Artists Rights Society (ARS), New York/Sociedad Mexicana de Autores de las Artes Plásticas (SOMAAP), Mexico City
